Advisory Visit

River Vartry, Co. Wicklow, Ireland

24th & 25th February 2016

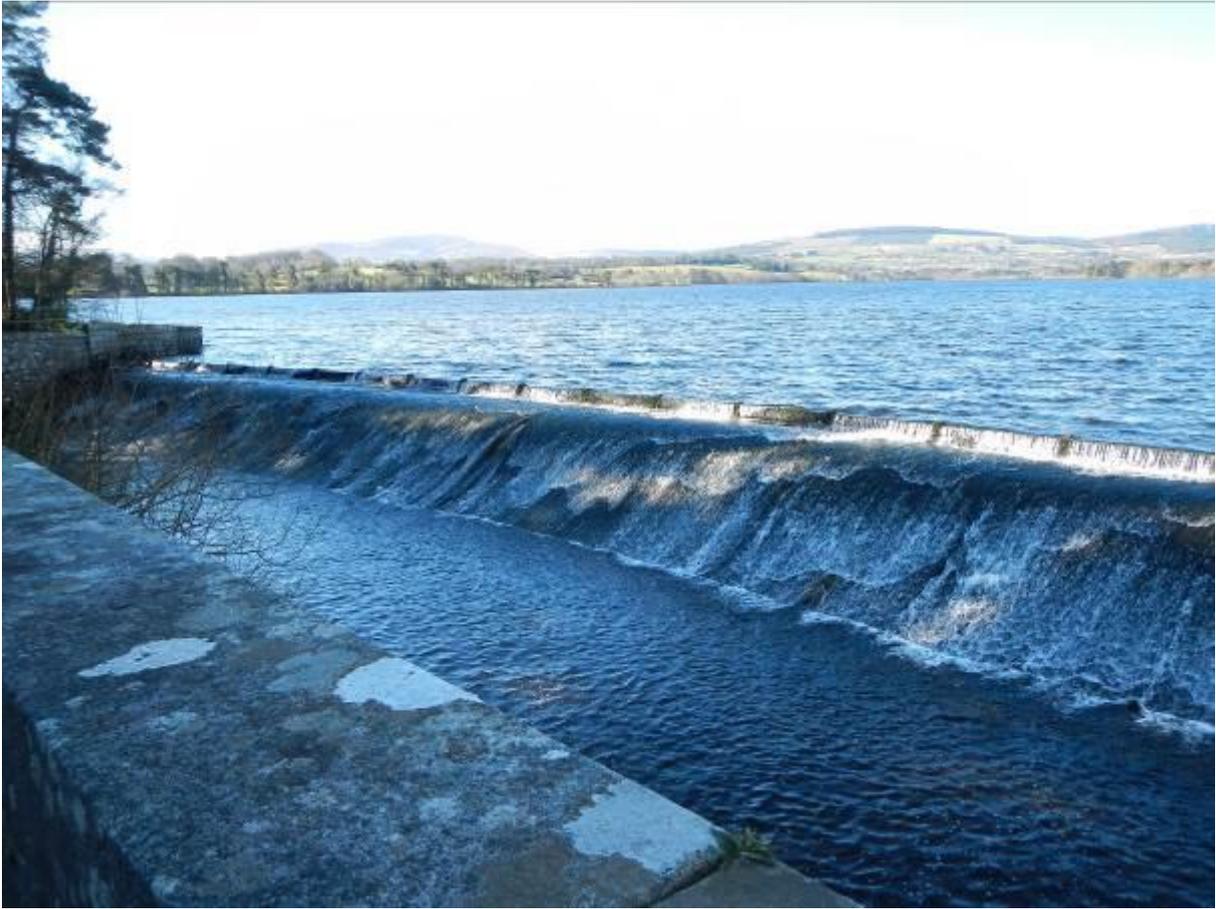
Figure 1. The Vartry Dam poses an impassable barrier to fish migration and effectively encloses the VACC waters at the u/s limit.

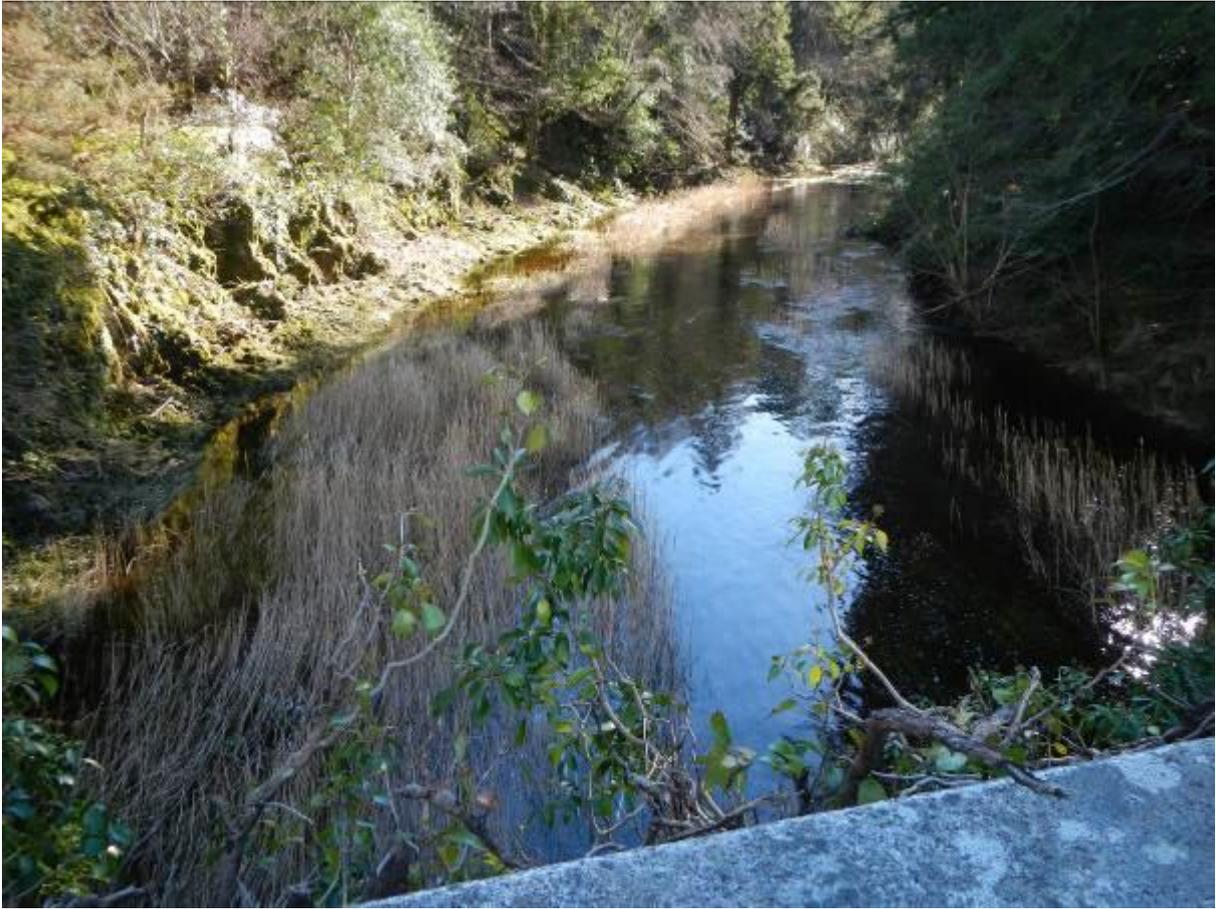
Figure 2. Immediately d/s of Vartry Reservoir – emergent vegetation encroaching into the channel suggests a significant discrepancy between the flows observed and low summer conditions.

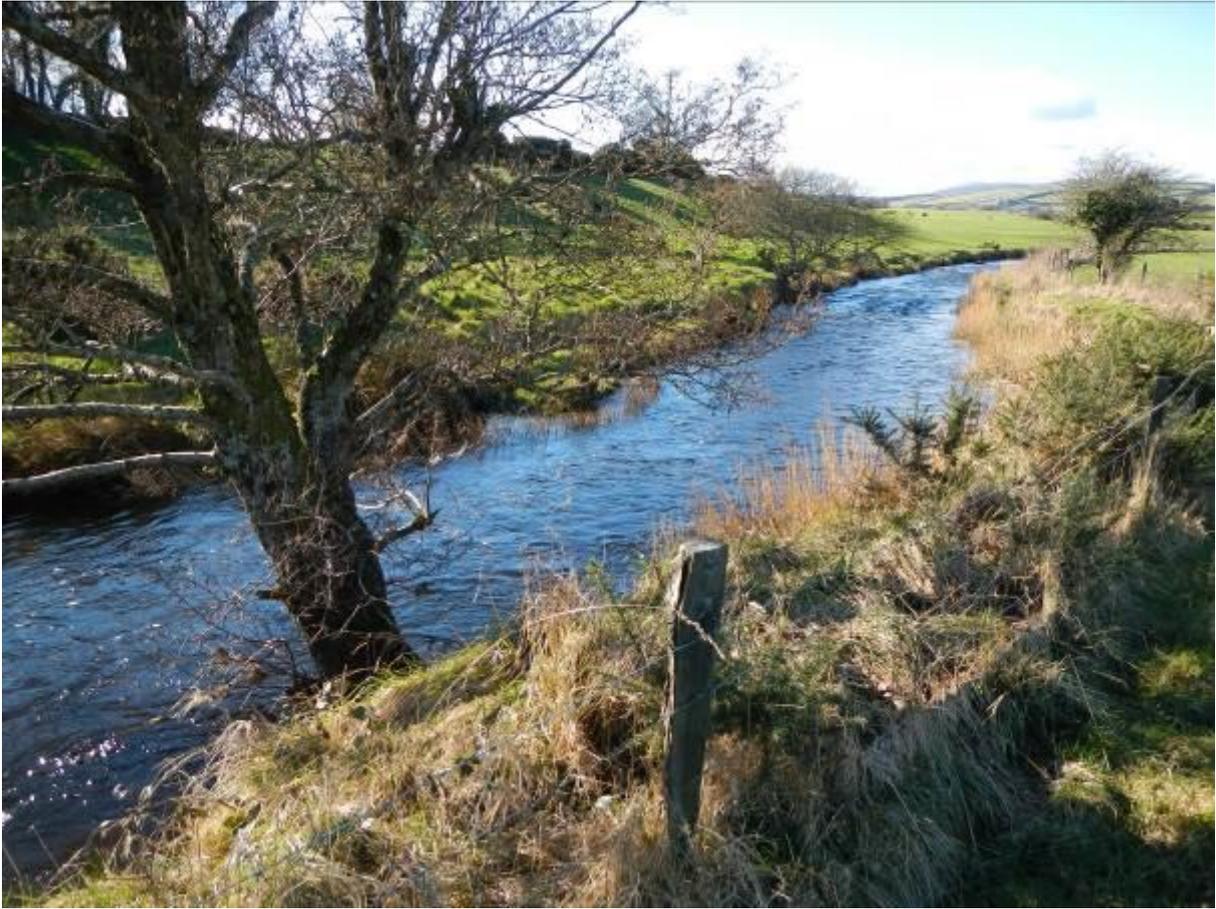
An un-grazed buffer protects the banks and channel from livestock access in many areas, allowing the development of a natural, roughly vegetated river margin and stable banks (Figs. 3 & 4); this also helps to limit inputs of fine sediment through reduced erosion and by intercepting any surface runoff. Where present, bankside trees provide valuable shade and cover, although a few additional trees would further improve habitat quality. River substrate is adequately sorted to provide habitat for healthy invertebrate communities and salmonid spawning, aided by little obvious bank erosion and fine sediment input.

Figure 3. Where present, riverside fencing provides a valuable buffer from the adjacent agricultural land and has facilitated the development of a healthy, roughly vegetated river bank.

If the knotweed issue can be controlled, it is recommended that a buffer fence be installed along all grazed river bank sections to exclude livestock. This will then allow the development of more extensive vegetation that will provide improvements to both habitat and bank stability.

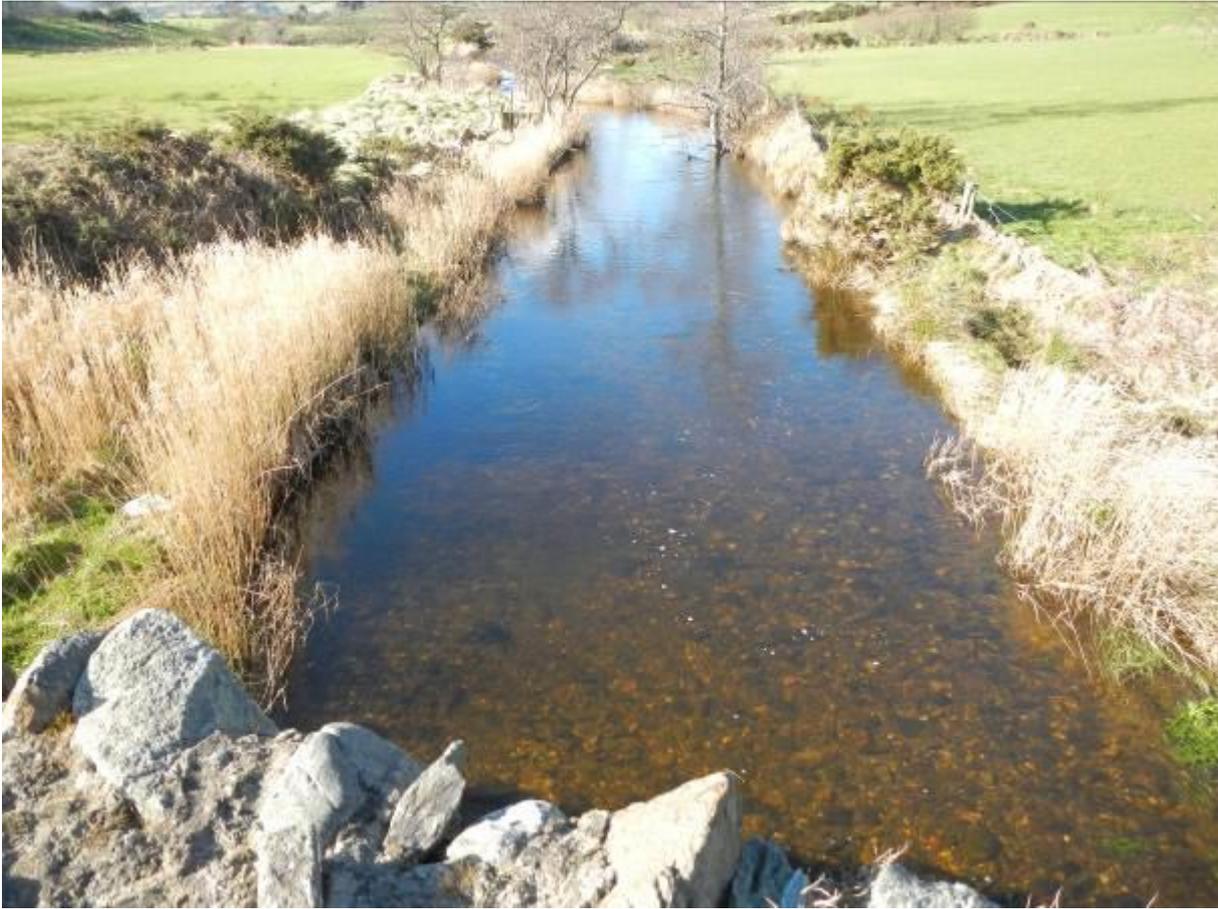
Figure 4. Looking u/s from Annagolan Bridge. The river supports some high quality habitats with marginal cover, stable banks and a gravel and cobble substrate; however, the channel does appear unnaturally straight in many areas.

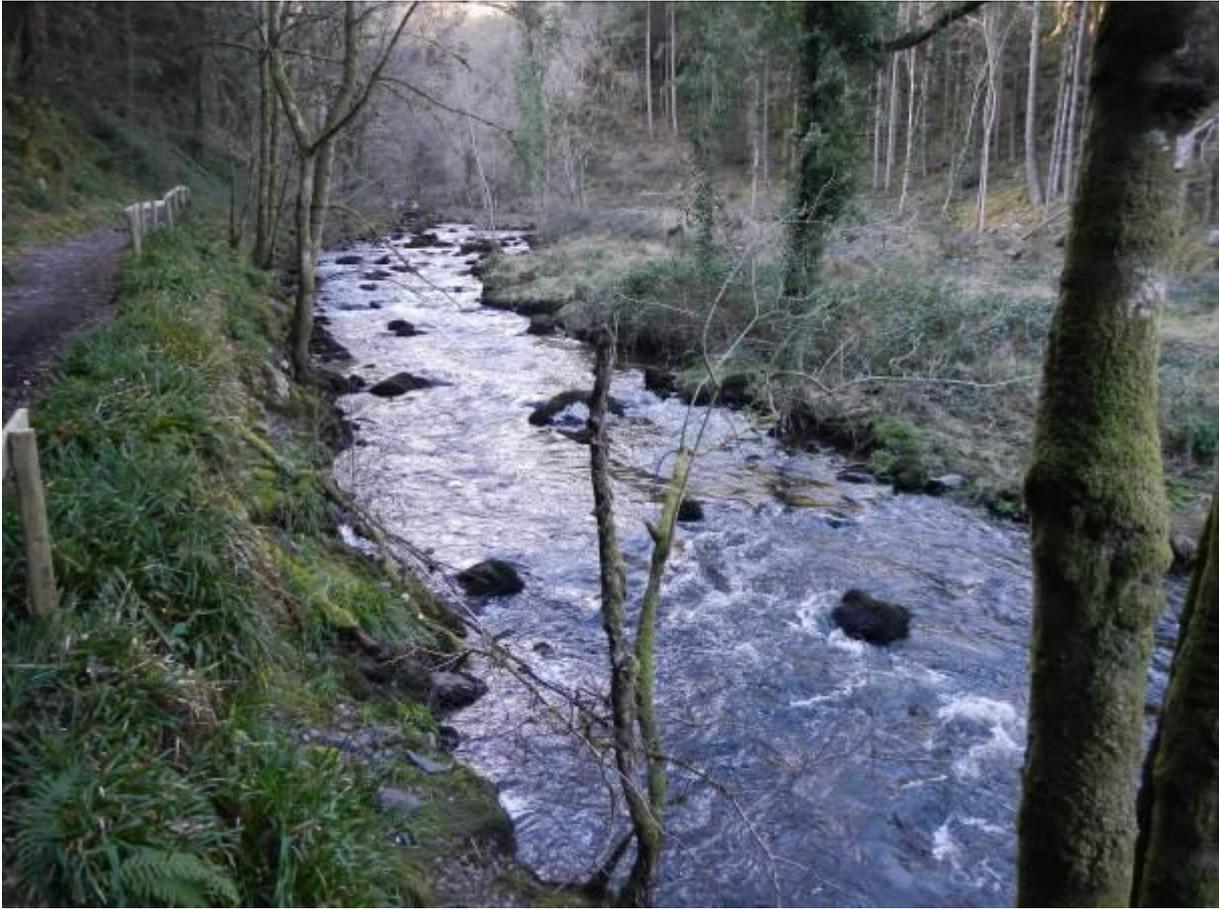
The valley alters markedly d/s of the wide, low gradient section, forming Devil's Glen, a steep gradient, high-sided bedrock and bolder gorge (Fig. 5). Owing to the constrained nature and gradient, the finer gravel substrate is naturally washed through many areas, only being retained in discrete pockets where reduced gradient and in-channel structure dissipates the flow energy (Fig. 6). The generally coarse nature of the substrate here is therefore a natural occurrence, owing to the physics of the area, and not something to be unduly concerned about. Areas capable of supporting spawning are present in lower energy areas at the tails of larger pools etc. and the rest is excellent juvenile habitat.

Figure 5. Looking u/s within Devil's Glen. High quality juvenile salmonid habitat and a few niches for resident trout. Juvenile salmonids may disperse u/s to such sections from spawning areas d/s, as well as more obvious d/s dispersals from gravel pockets further u/s.

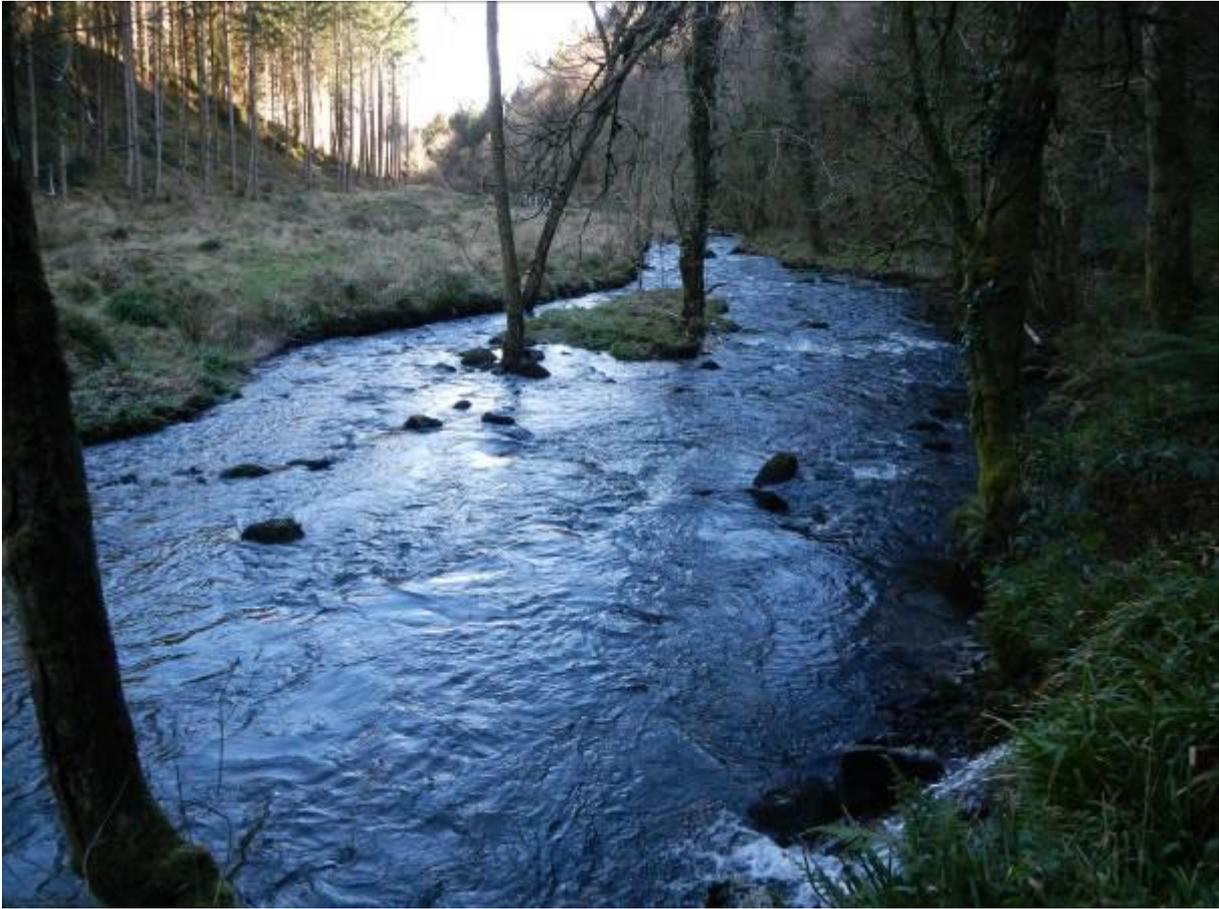
Figure 6. Discrete pockets of finer cobbles and gravel suitable for salmonid spawning are deposited in some areas, often towards the tail of larger pools and around structure like trees and boulders.

There is no lack of gravel and cobble substrate within the system and trying to input gravel within the gorge is likely to be unsustainable long-term as it would simply wash out. In addition, d/s of the gorge, where the gradient reduces and valley widens, gravel is again retained naturally. Spawning fish will take advantage of these areas where they naturally occur and if they are d/s of juvenile habitat, juveniles often disperse u/s to take advantage of it. This highlights another important reason for maintaining fish passage in a natural free state and for removing obstructions wherever possible.

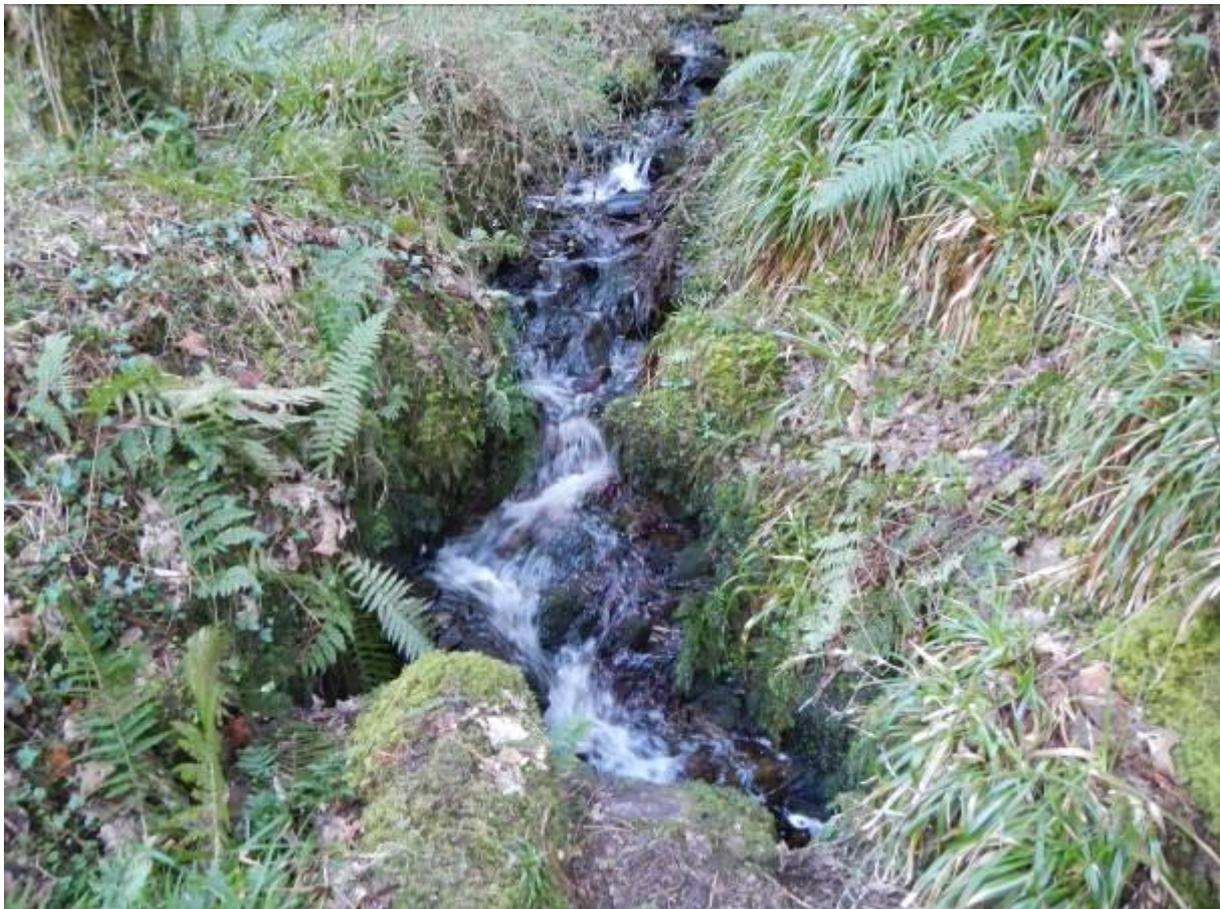
Figure 7. Most tributaries entering the Devil's Glen section are too steep to be utilised by fish.

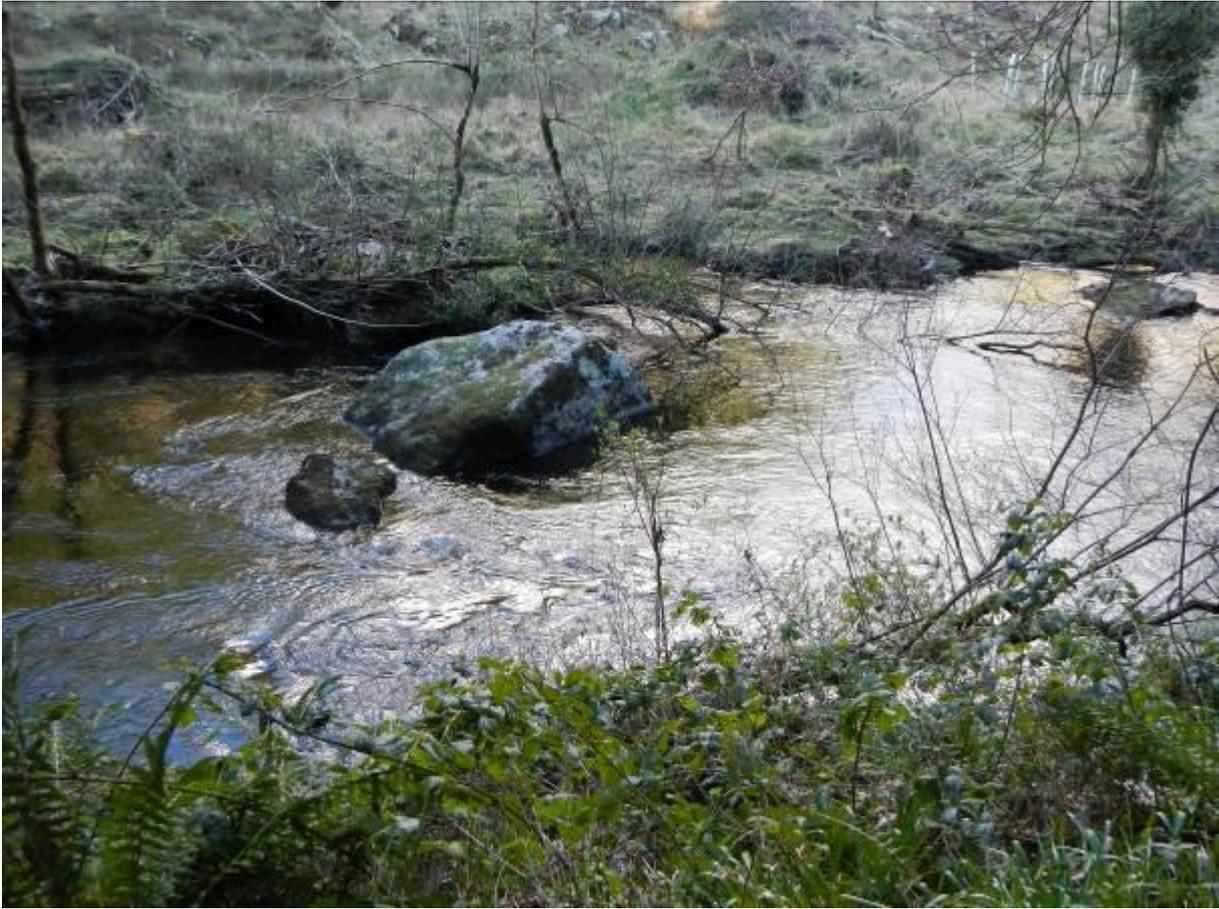
As well as providing dissipation of flow energy, the few deeper pool areas within the gorge also provide important resting/refuge areas for larger migratory salmonids and possibly the occasional adult resident trout (Fig. 8). Fish will accumulate around these areas in the lead up to spawning time, taking advantage of the deeper water refuge and often cooler temperatures, before dispersing out onto the suitable gravel and cobble areas to spawn. Maintaining structure/cover within these areas of channel is therefore important to provide security and protection from predators.

Figure 8. Deeper pool areas within the gorge will provide valuable refuge for larger fish. Overhanging and trailing trees/vegetation offers them valuable cover and security.

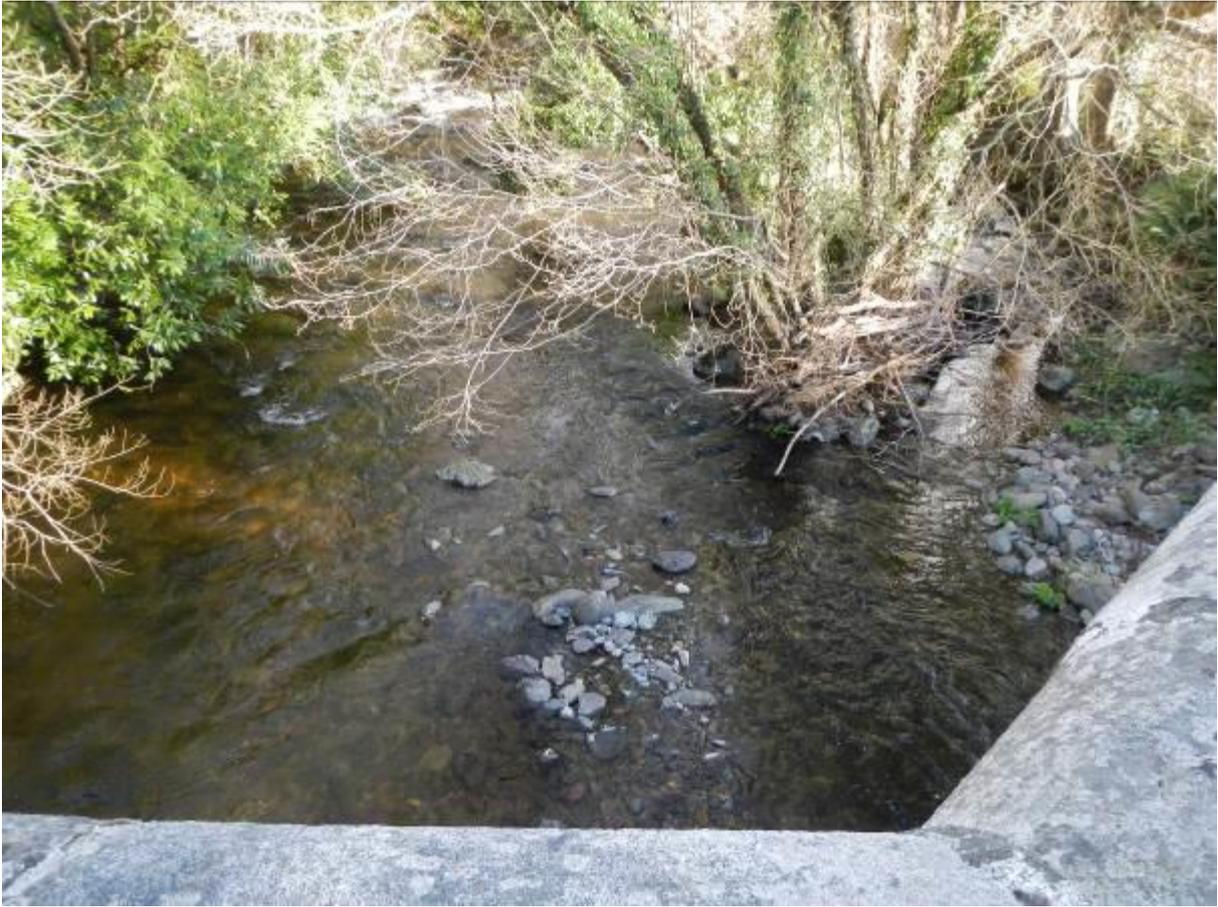
The valley starts to widen out again d/s of Devil's Glen and the river gradient decreases, increasing the occurrence of gravel and cobble deposition (Fig. 9). This provides more potential spawning habitat, diversifies habitat for juvenile salmonids and invertebrates. Only a spot check was undertaken at Nunn's Cross Bridge (Fig. 9) but further inspection of this area was undertaken from Ashford, working u/s and into the d/s of the woodland where valuable lower gradient wooded river habitat is present.

Figure 9. Looking u/s from Nunn's Cross Bridge. The lower gradient (compared to Devil's Glen u/s) here and d/s through the woodland naturally facilitates retention of a wider range of substrate sizes.

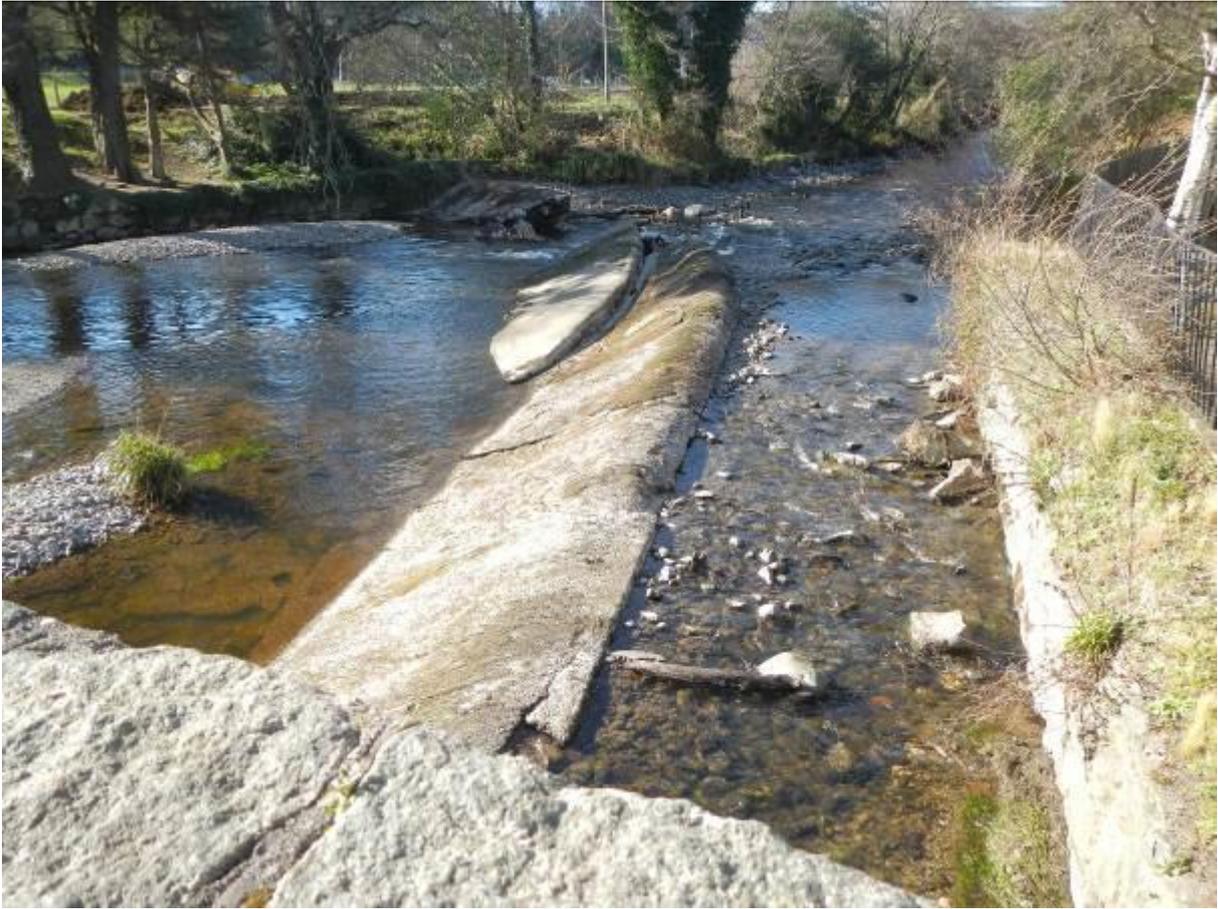
Figure 10. The remains of Ashford Weir. Collapse of the central section of this weir has facilitated the significant habitat improvements u/s, reinstated sediment transport through the area and greatly improved habitat connectivity/fish passage.

The disintegration of the large weir in Ashford is undoubtedly a major improvement to habitat quality and connectivity, greatly improving fish passage and sediment transport through the site. As the weir is now largely obsolete anyway, it is strongly recommended that any plans to reinstate the weir are prevented, citing the significant detriment to the river of doing so. Some work to improve the aesthetics of the structure may be beneficial but it should be ensured that no alterations to the continuity of natural river bed be made.

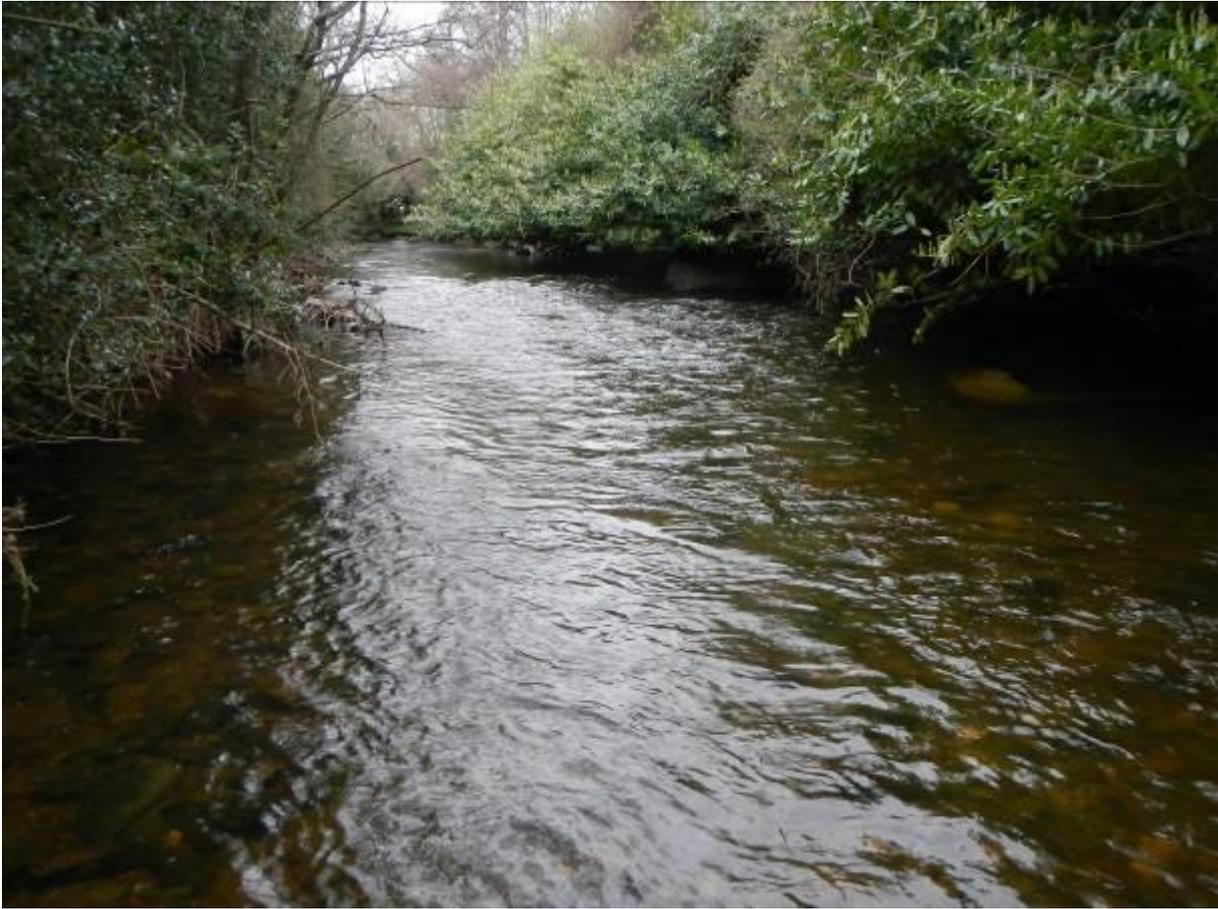
Figure 11. The once-impounded river section now provides a diverse range of high quality habitat. Laurel provides some good cover but it would be better removed to allow natural species colonisation.

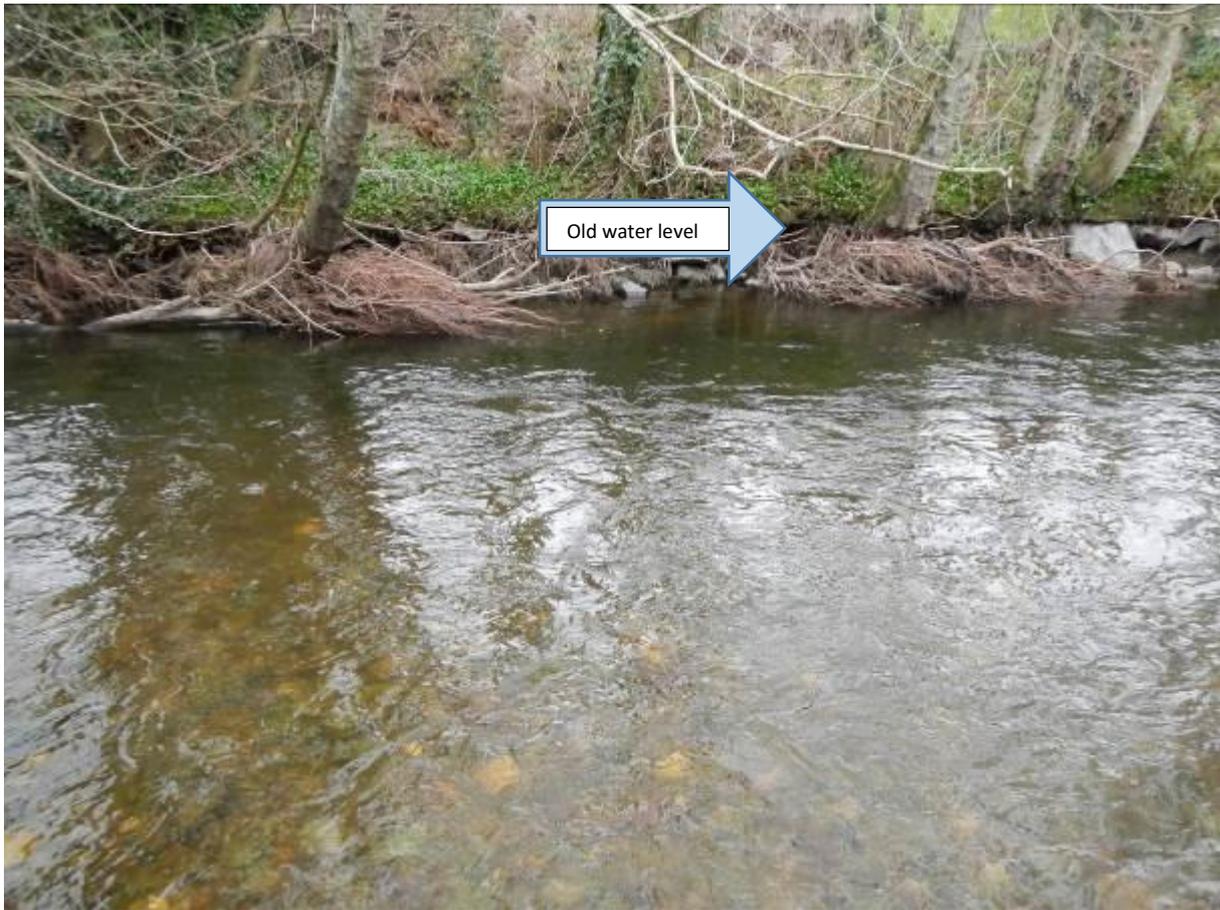
The once impounded section now supports high quality riffle and glide habitat with a healthy abundance of low-level branches and trailing/submerged root cover (Fig. 12). This area was previously an easy hunting ground for predators and poachers, undoubtedly increasing losses of juvenile fish (including smolts) on their d/s migration, acting as an ideal spot where fish-eating birds could easily corral fish.

Figure 12. High quality deep glide habitat with readily available overhanging/in-channel cover. Note the greatly reduced water depth owing to the loss of the impoundment d/s. This has re-energised flows and returned the section to the high quality habitat it should naturally provide.

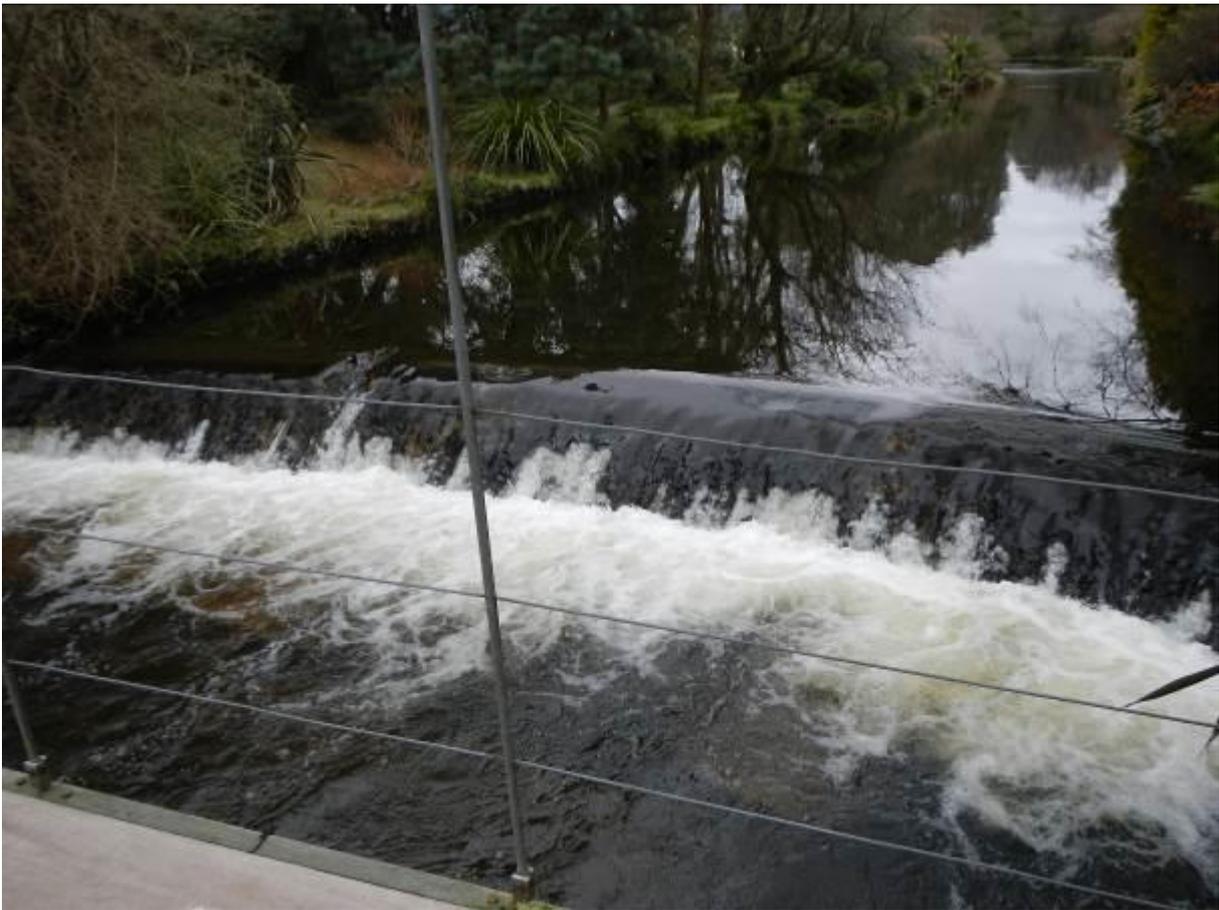
Figure 13. The largest weir in Mt. Usher Gardens. This is a sizeable obstruction and likely to inhibit fish passage, particularly at low flows and for the vital smaller/juvenile fish that are often overlooked.

Several other barriers to fish movement are also present on the river. These potentially fragment fish populations along the watercourse and pose additional stresses to wild fish stocks. Without the ability to move freely u/s and d/s in a river, fish are deprived of the ability to move between the various habitat types required to fulfil their lifecycle and to achieve optimal utilisation of habitats through natural dispersal. It is appreciated that the weirs may provide aesthetic amenity value to other users of the area but it is recommended that discussion is entered into with the owners to ascertain if any of those structures could be removed and whether easements or passes could be installed on any that absolutely cannot.

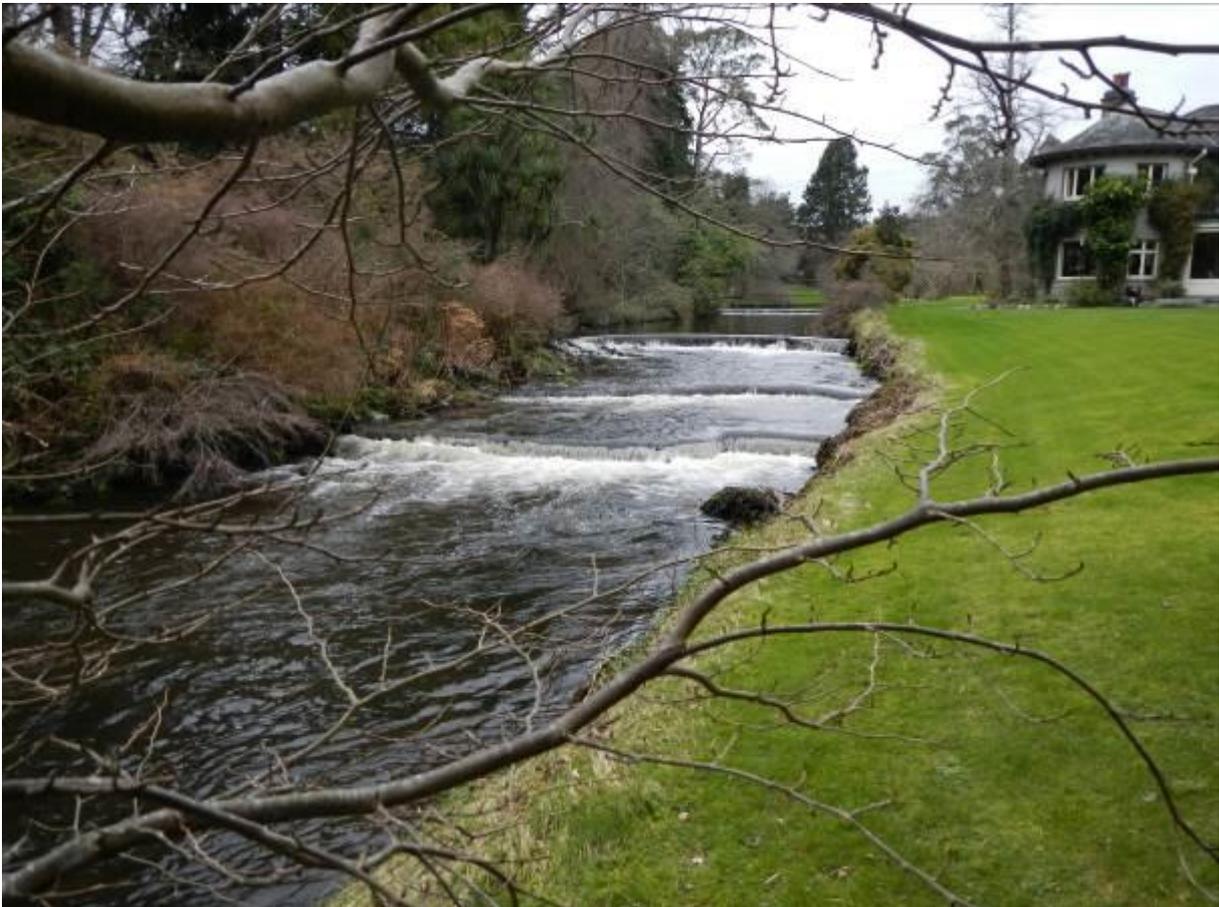
Figure 14. Series of weirs/adapted natural bedrock structures. The closely mown river margins on the LB (right of shot) also greatly reduces habitat quality within the pools and the cover available to fish trapped within them.

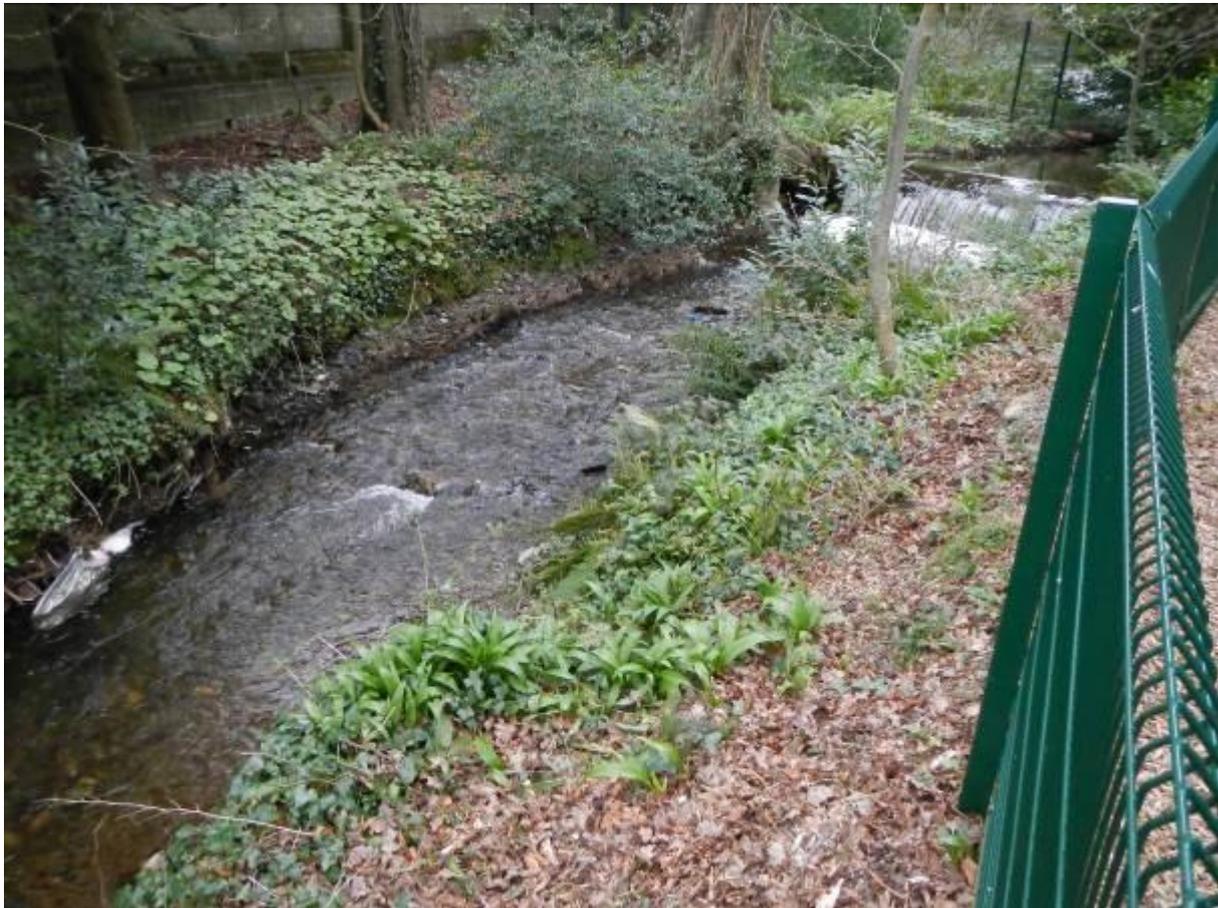
Figure 15. The farthest u/s location inspected on the tributary, showing the first of two co-located, impassable weirs. Habitat d/s is suitable for spawning and juvenile salmonids.

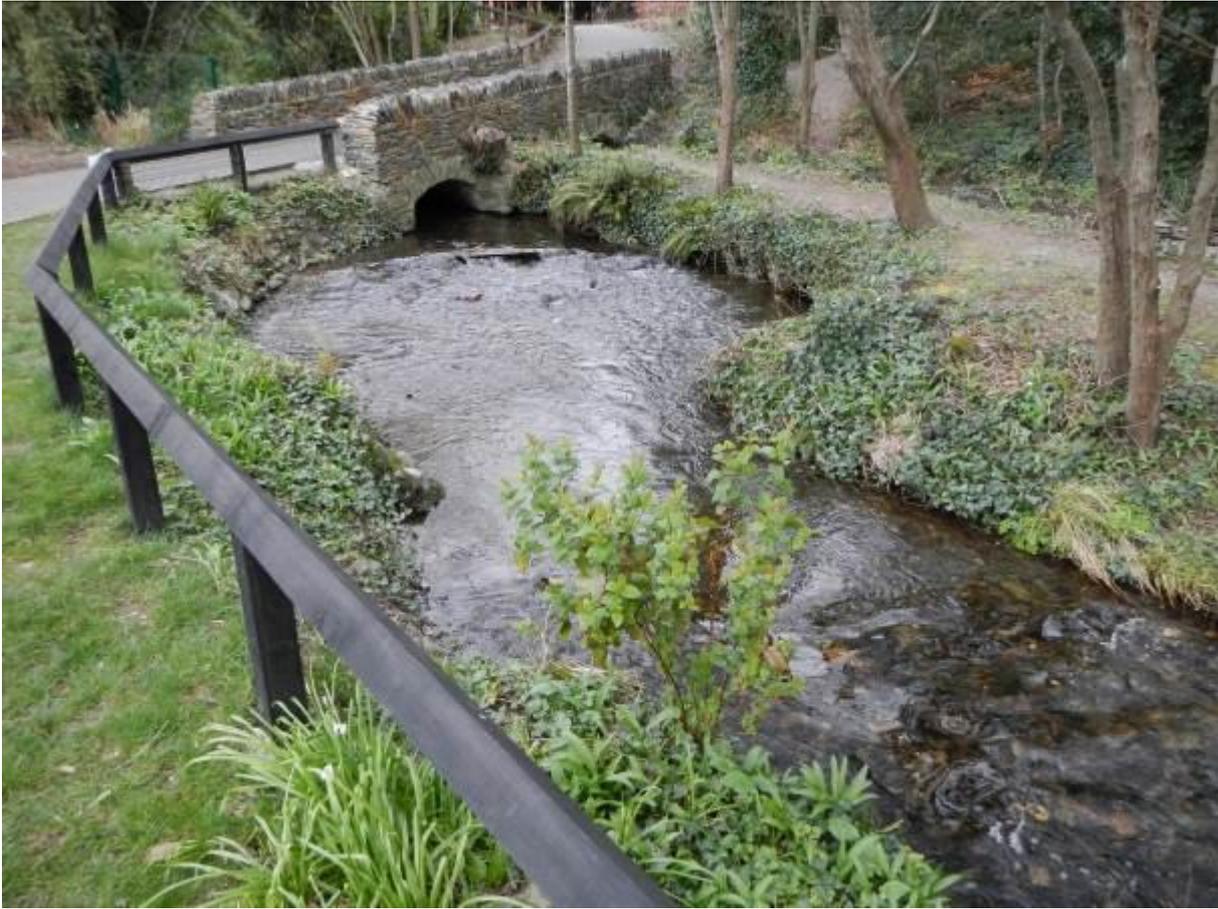
At the children's play area (farthest u/s location inspected on the tributary) two large, near impassable manmade weirs effectively prevent further u/s passage although habitat above the weirs offers further potential spawning and juvenile habitat if access were restored, as does the watercourse d/s though the park (Figs. 15 & 16).

Figure 16. Habitat within the park is of a reasonable quality for spawning and juvenile salmonids, if a little exposed and lacking low cover.

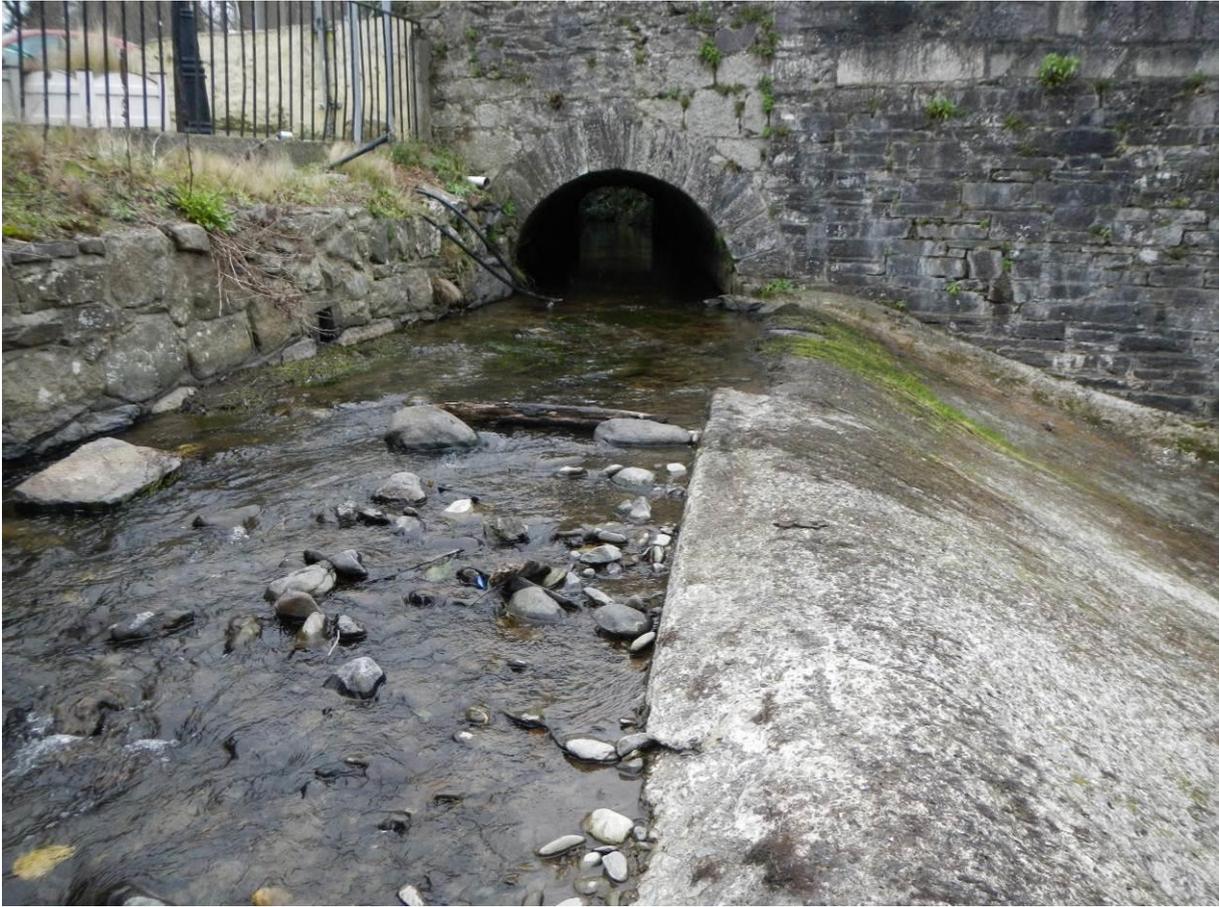
A short distance d/s, a leat that once supplied water from Ashford Weir into the tributary remains connected but now seemingly takes a portion of the flow from the tributary and discharges to the River Vartry at the u/s side of the Ashford Weir (Fig. 17). Although this reduces flow within the tributary d/s of this point, it may ultimately make the tributary more accessible for fish from the main river (via the leat), particularly to the park and children's play area. Flow and substrate in the visible section of the leat suggests that it too could provide potential spawning and juvenile habitat and may be worth enhancing. However, further inspection is required to confirm there are no additional barriers to fish movement within the leat.

Figure 17. Leat connecting the tributary with the u/s side of the remains of Ashford Weir.

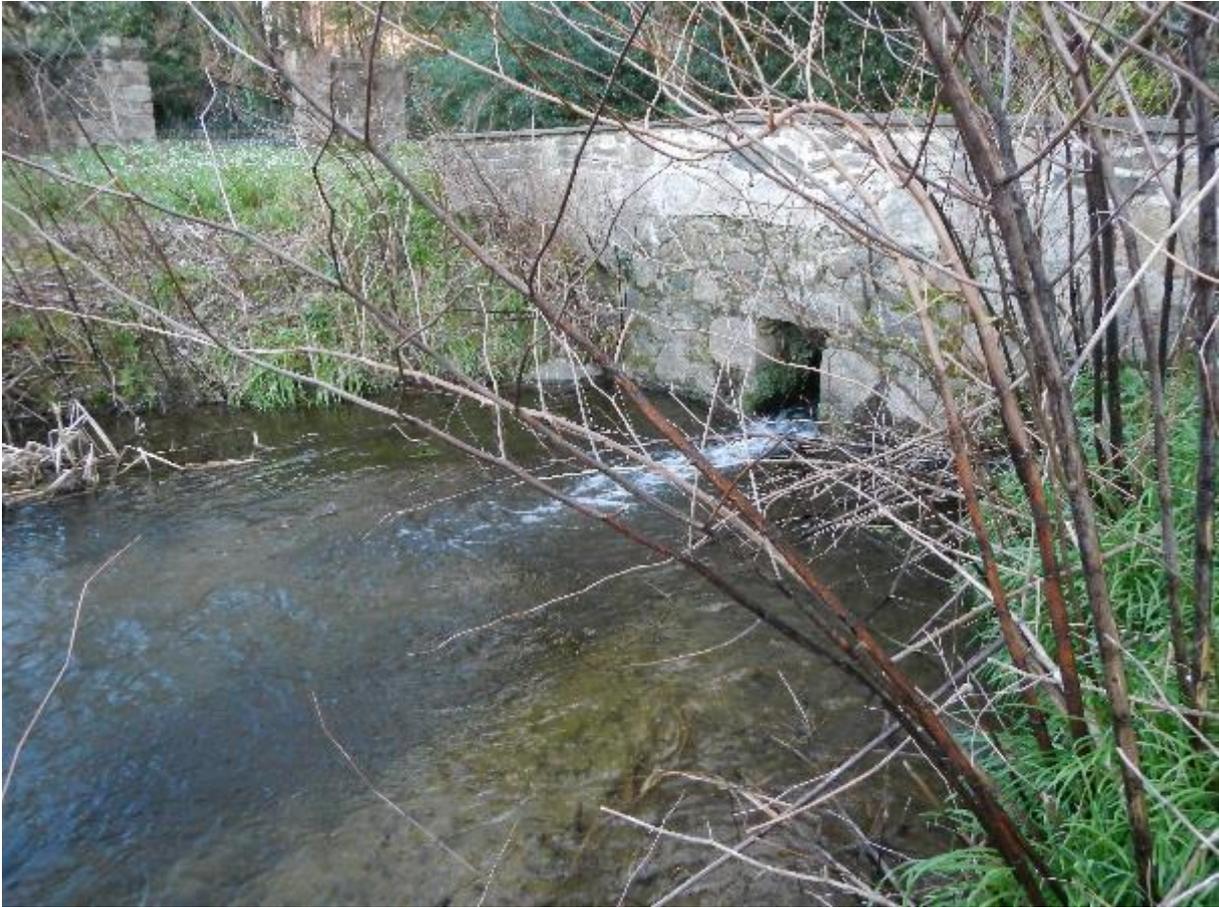
Figure 18. Sluice feeding a pond and additional channel d/s of the pond from the main tributary. In addition to poor passability through the sluice, an overflow at the d/s end of the pond also restricts u/s migration via this route. Also note the Japanese knotweed (brown canes - right of shot).
