Advisory Visit

River Vartry, Co. Wicklow, Ireland

24th & 25th February 2016

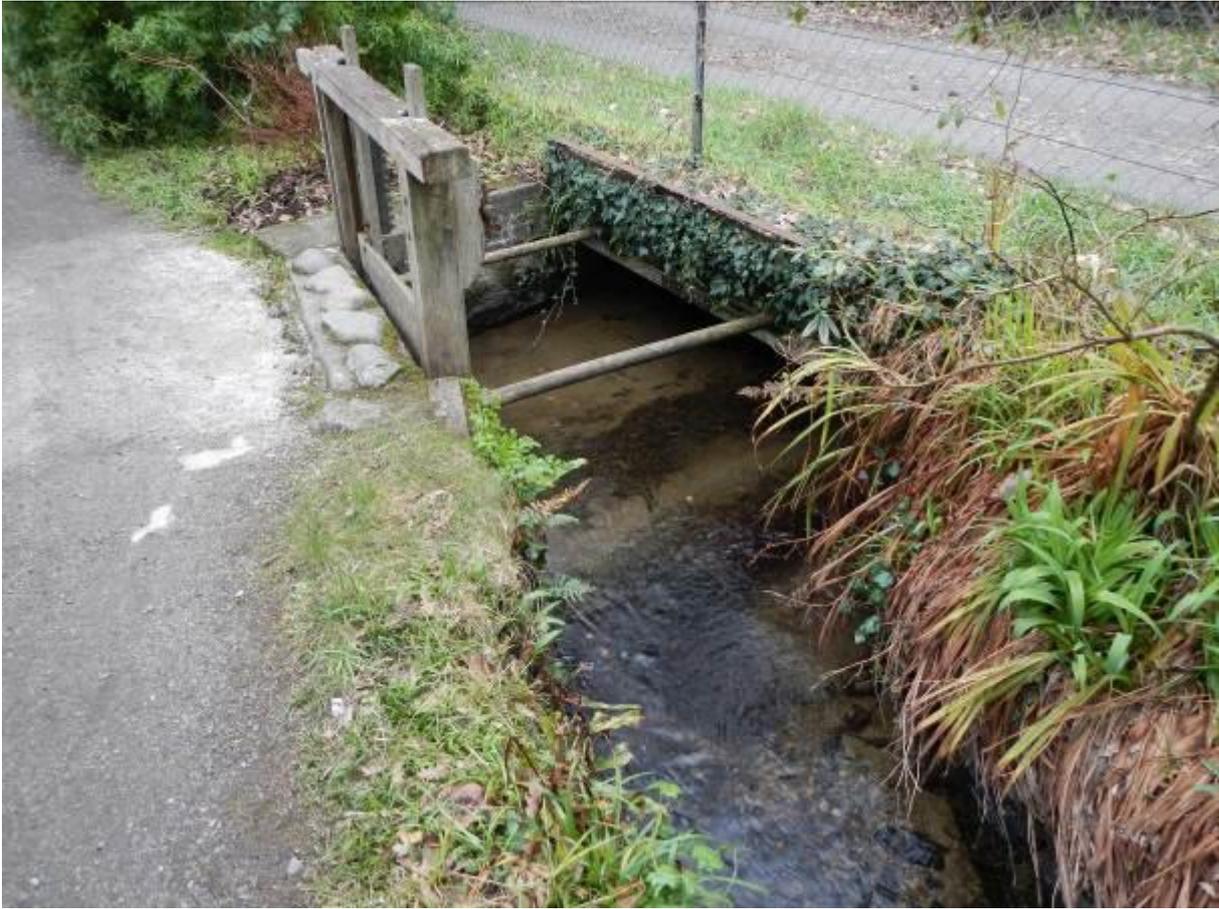
Further d/s on the tributary, several structures are used to regulate flows and are likely to pose barriers to fish passage u/s through the channels within Mt. Usher Gdns and probably d/s. The barriers include sluices (Figs. 18 & 19), weirs (Figs. 20 & 21) and culverts/piped channel sections. The impact of these structures should ideally be assessed from the least passable and farthest d/s of the structures as these effectively form the limiting factor.

Figure 19. Sluice that further splits flow from the main flow of the tributary and supplies the small channel re-joining the main channel d/s of the falls in section depicted in Figure 21.

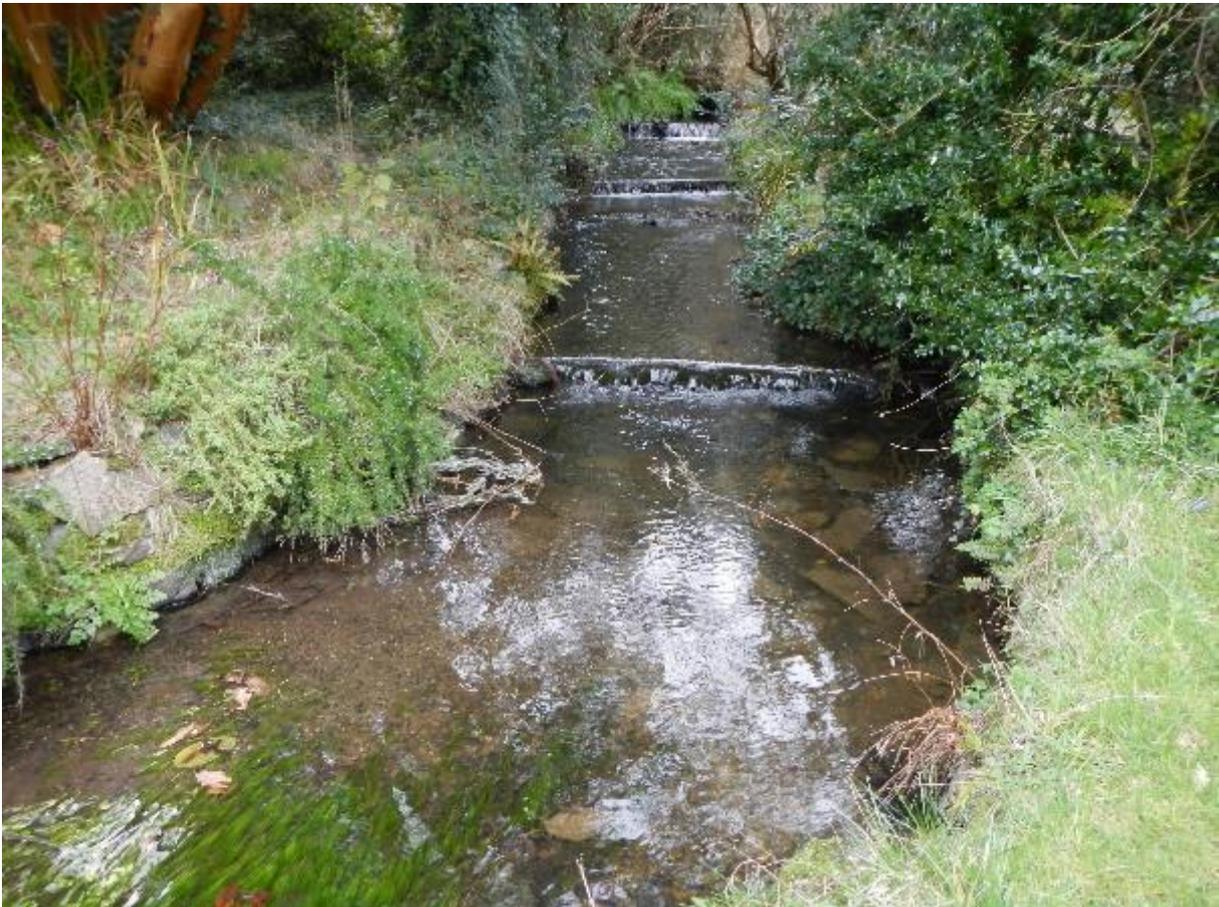
Figure 20. Small weirs that degrade habitat but are of minimal impact owing to the barrier d/s (Fig. 21).

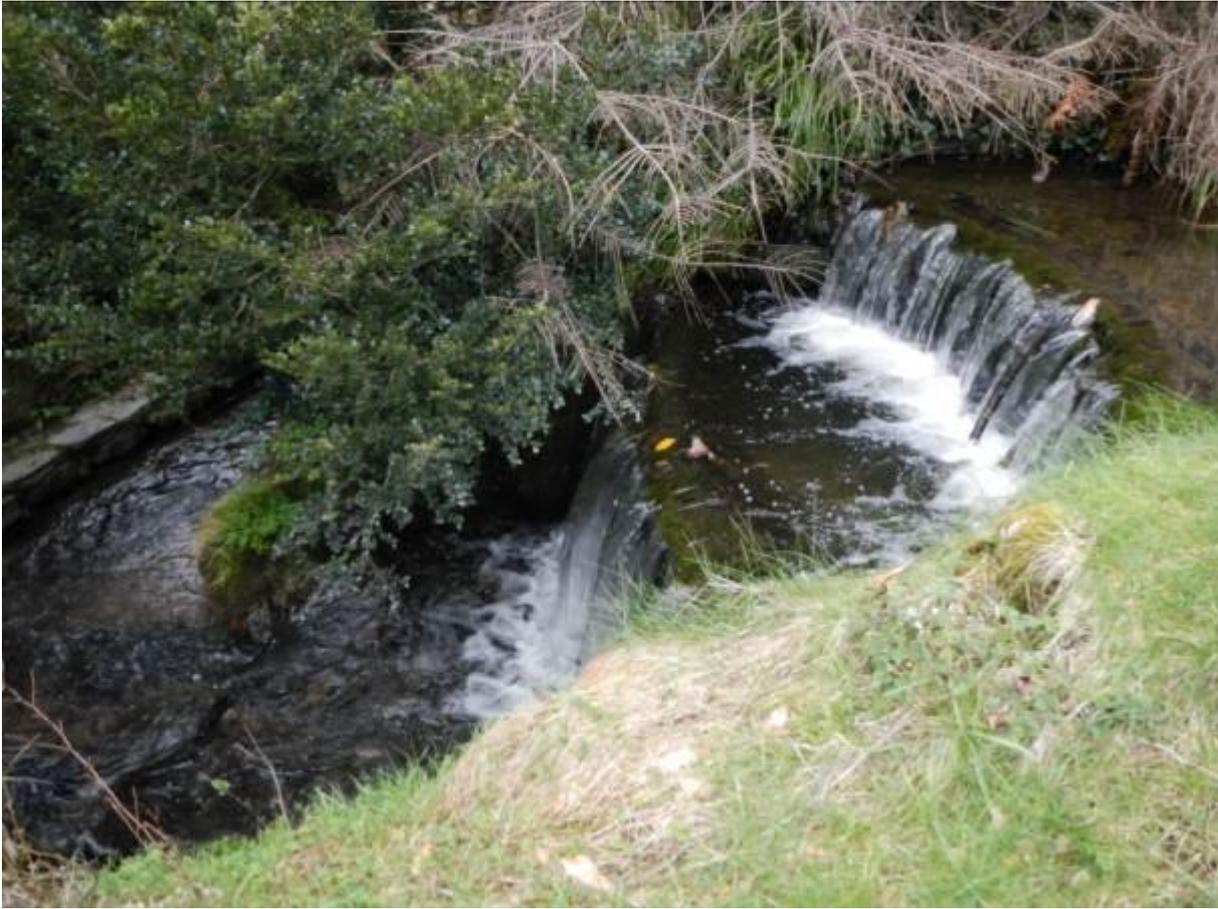
Figure 21. Semi-natural barrier that is likely to prevent u/s access on the main stem of the tributary.

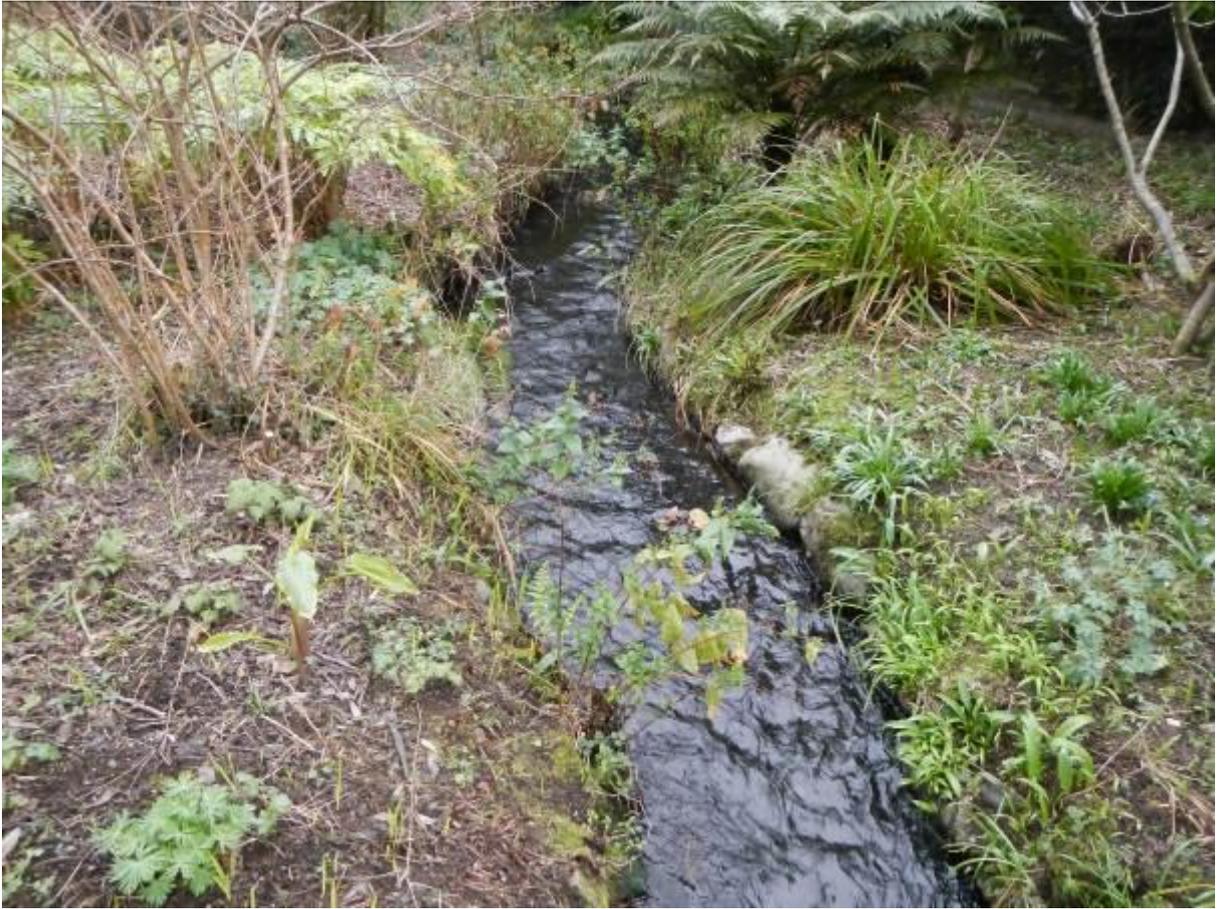
The large semi-natural waterfall (Fig. 21) and another large structure on the adjacent smaller side-channel render the two farthest d/s channels largely inaccessible (barring the lower 100m of low value habitat) and the overspill at the d/s end of the pond and sluice on the other channel u/s (Fig. 18) also preclude migration through those routes. This leaves only a short distance of channel d/s of the pond (Fig. 18) accessible from the main river and although the habitat is of limited quality (Fig. 22), there were some signs of attempted spawning activity there, likely because fish that are unable to reach adequate spawning areas had to make do (Fig. 23). It might be worth enhancing this lower channel for spawning with the inclusion of gravels as, on a small, low-energy tributary/artificial channel, they are more likely to be retained.

Figure 22. Relatively poor quality habitat in the accessible but artificial channel section in the Gardens, d/s of the pond depicted in Fig. 18.

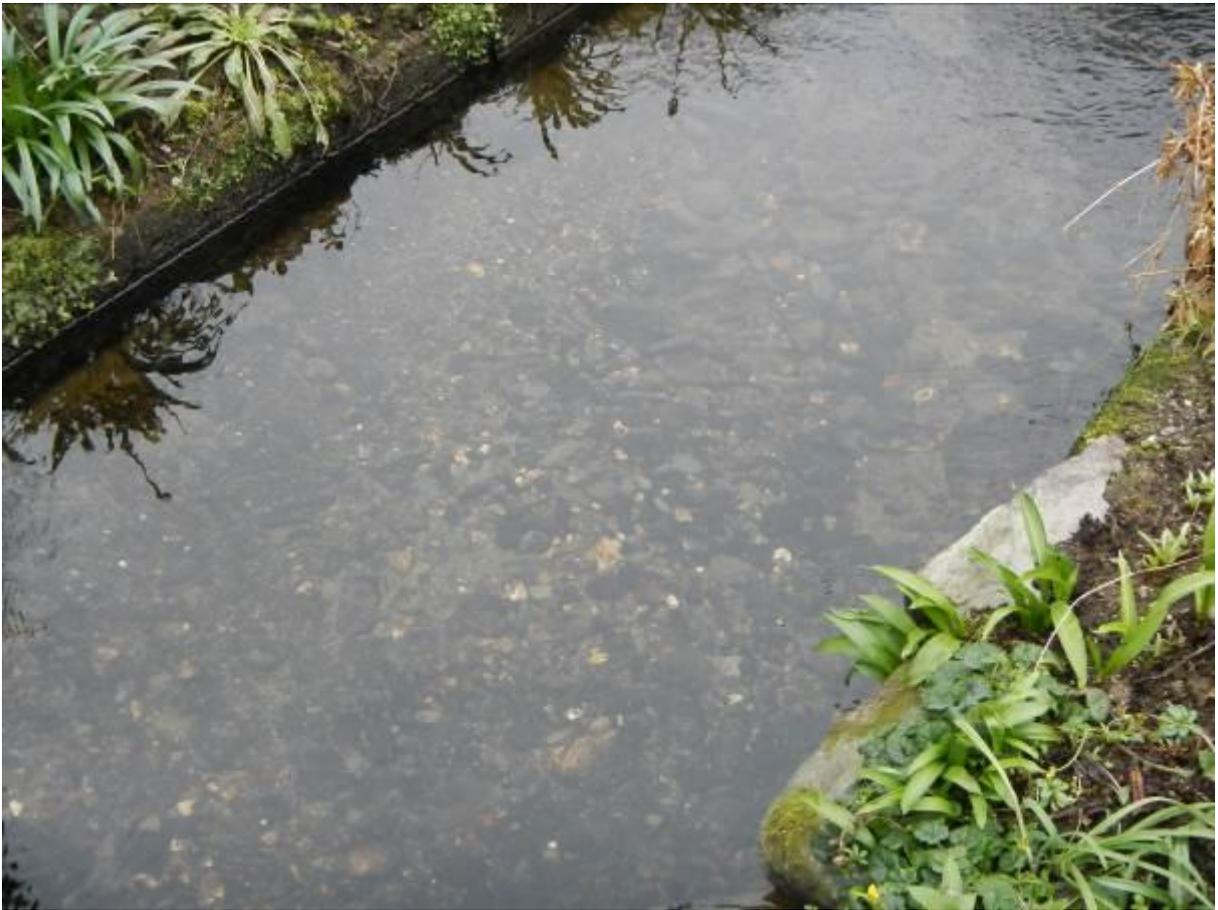
Figure 23. Despite the poor quality of the channel d/s of the pond some signs of spawning activity were observed on the bed.

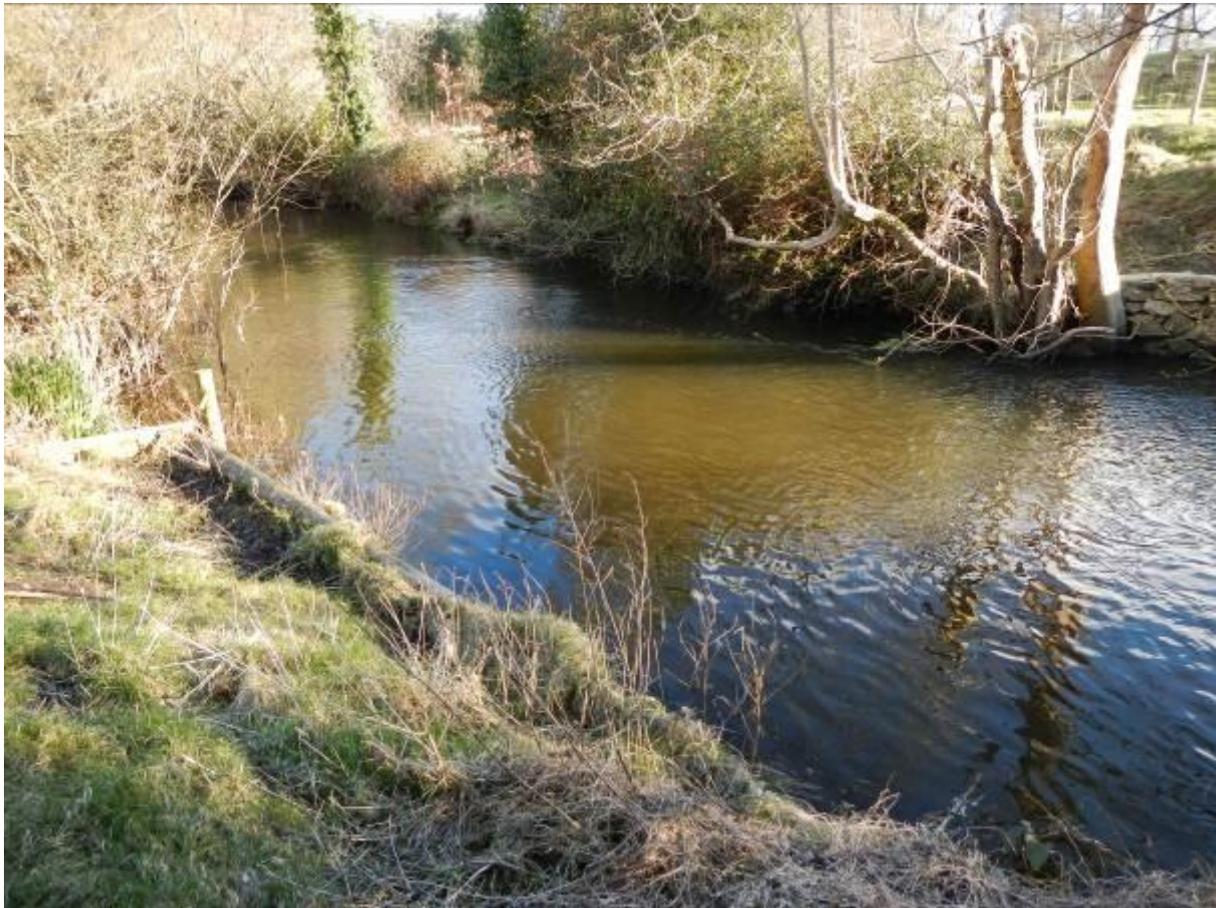
Through the farmland d/s of Ashford, the gradient of the channel reduces further and a more natural channel than is present through Ashford provides a diversity of depths and flows with a greater availability of deeper natural pools (Fig. 24). Spawning and juvenile habitat remain available through this section but there is a notable increase in the availability of adult trout and migratory fish holding water. This section is also where the occasional larger resident brown trout have been caught (L Drea, 2016, pers. comm., 25 February).

Figure 24. In the lower gradient section of the River with a greater availability of deeper pool habitat.

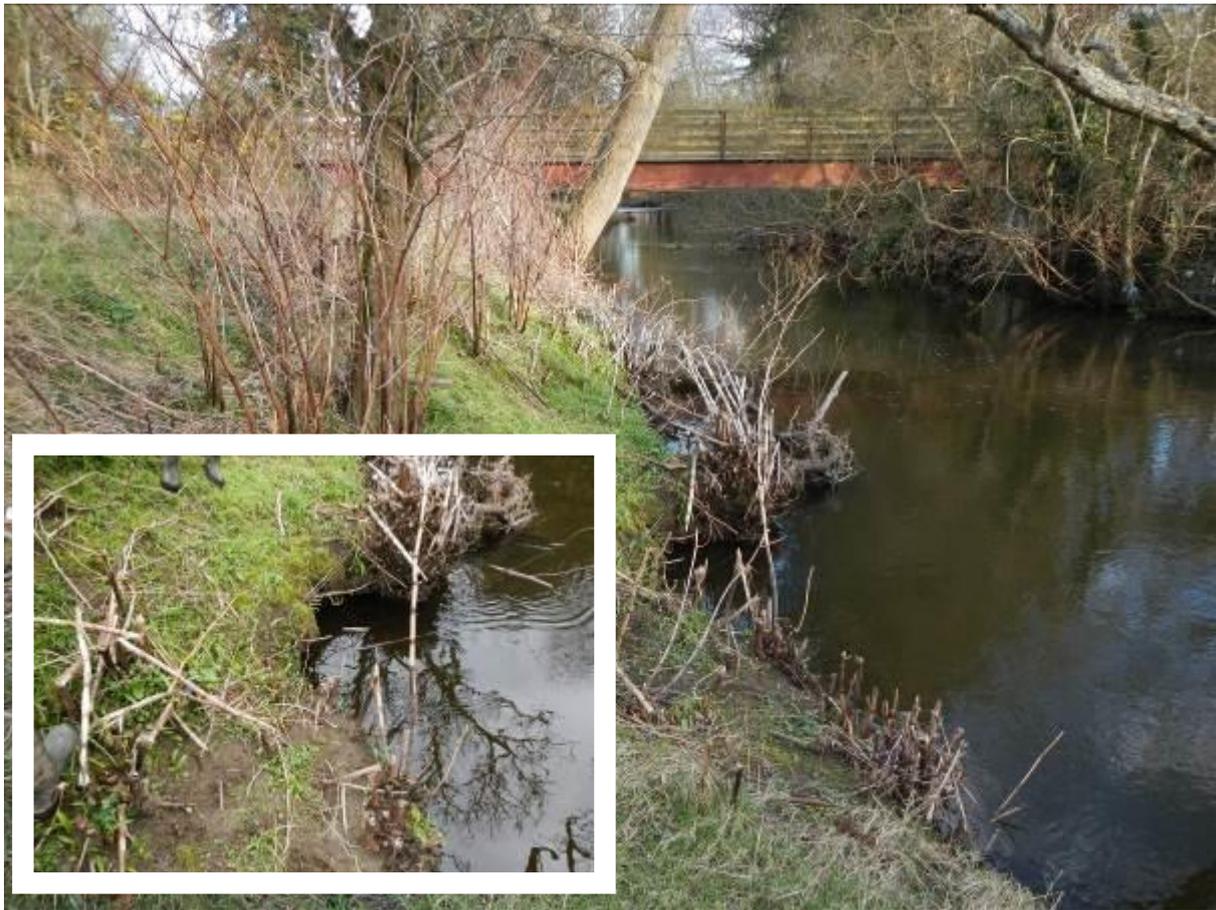
Figure 25. Japanese knotweed within a lightly grazed field. The grazing is not preventing its spread and the knotweed stand is leading to significant bank loss that it likely to further threaten the stability bank and neighbouring trees if left untreated.

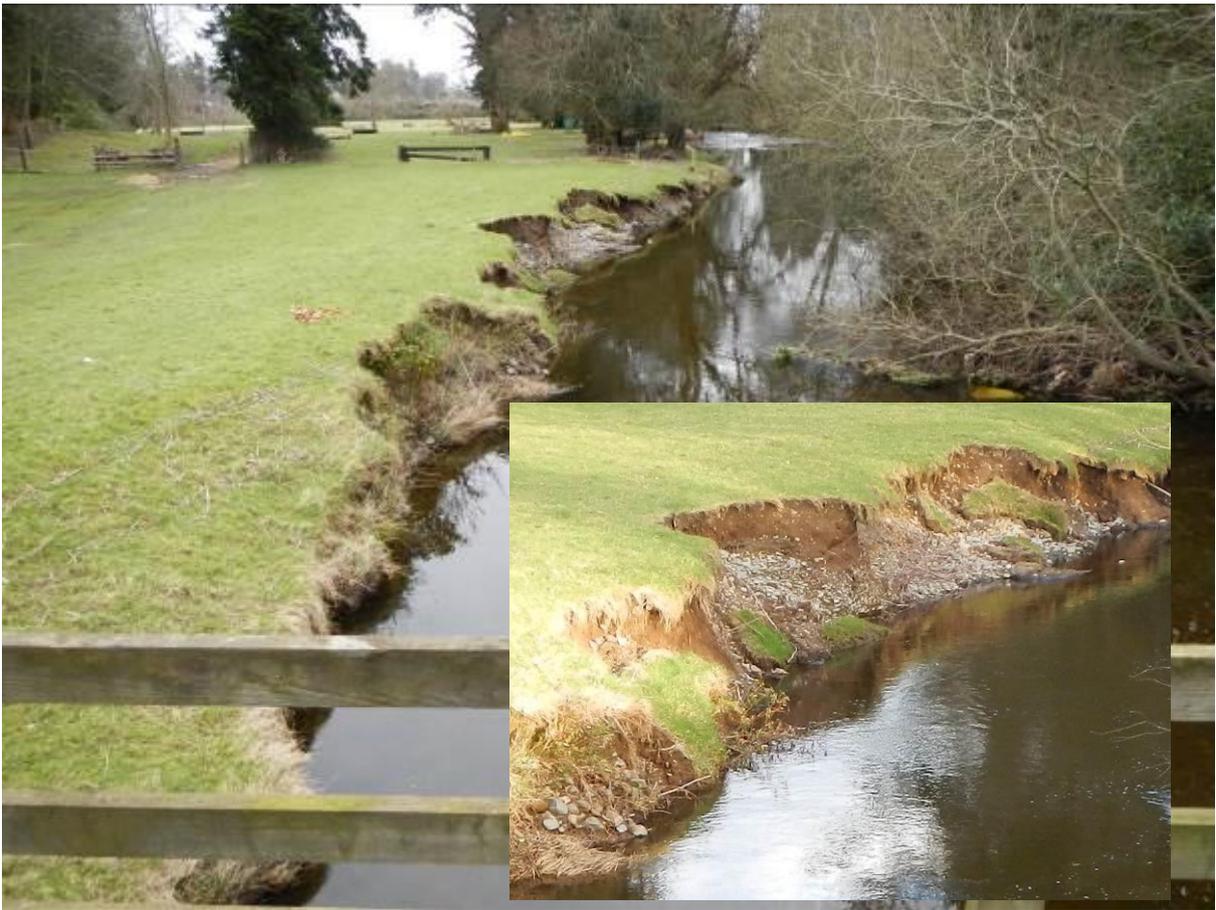
Figure 26. Significant bank erosion. Note the lack of root structure within the soil to bind it together and compare with Figure 27, within a well-vegetated buffer strip. In contrast, the tree-lined RB is stable and provides good quality cover and fish holding habitat.

Various techniques can also be employed to tackle areas of eroding banks with natural materials such as brash, as shown in the accompanying WTT bank protection document. It should be noted, however, that bank protection is unlikely to be sustainable long-term without addressing the non-native plant species issues that are causing the issues, in most cases. This is also true for the area in which the River is cutting across the bend at a fording point (Fig. 38), although roughening the bank with brash would start to address the issue of erosion as described previously and potentially reduce the issue.

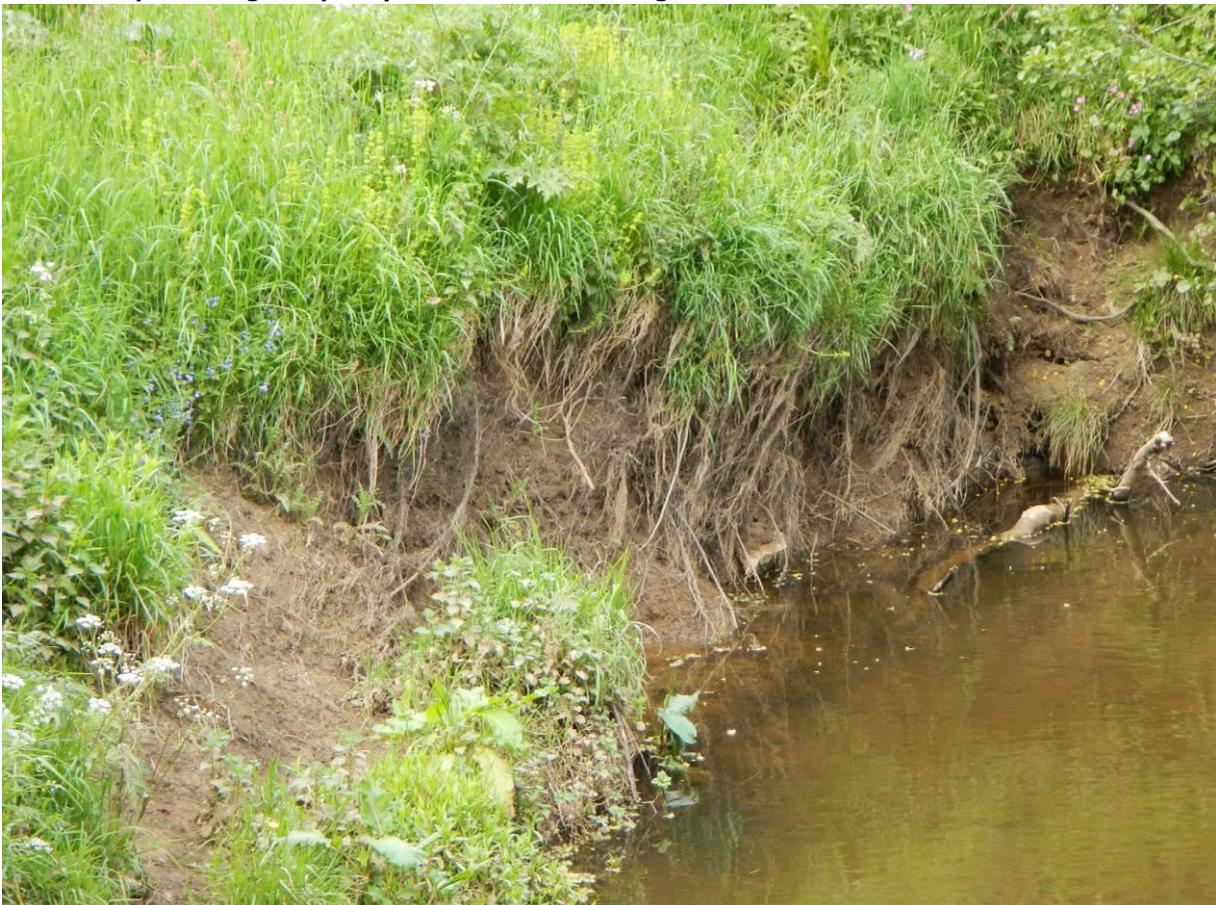
Management of riverbanks and adjacent fields is always complicated as livestock grazing alone leads to bank instability (Fig. 26). This is because the extent of root structures, and therefore consolidation of the soil, is related to the vegetation and foliage visible above the ground. Grasses are the only species capable of withstanding prolonged grazing pressure and alone, they do not provide very deep or diverse root systems, particularly when most of their growth is replacing foliage grazed above the ground, rather than extending their roots. Compare the very shallow root structure within the bank in Figure 26 with the extensive root matrices provided by a range of species within a fenced, well-vegetated buffer strip (Fig. 27); the erosion there occurred after a tree collapsed but the bank quickly recovered through the stability provided by other root systems.

Figure 27. With livestock excluded, grasses and other vegetation establish extensive foliage and root systems which offer far greater bank stability than grazed banks (Fig. 26); also allowing banks to naturally regrade following erosion. Management of non-native invasive species remains an issue.

If the knotweed issue can be controlled, it is recommended that a buffer fence be installed along all grazed river bank sections to exclude livestock. This will then allow the development of more extensive vegetation that will provide improvements to both habitat and bank stability.

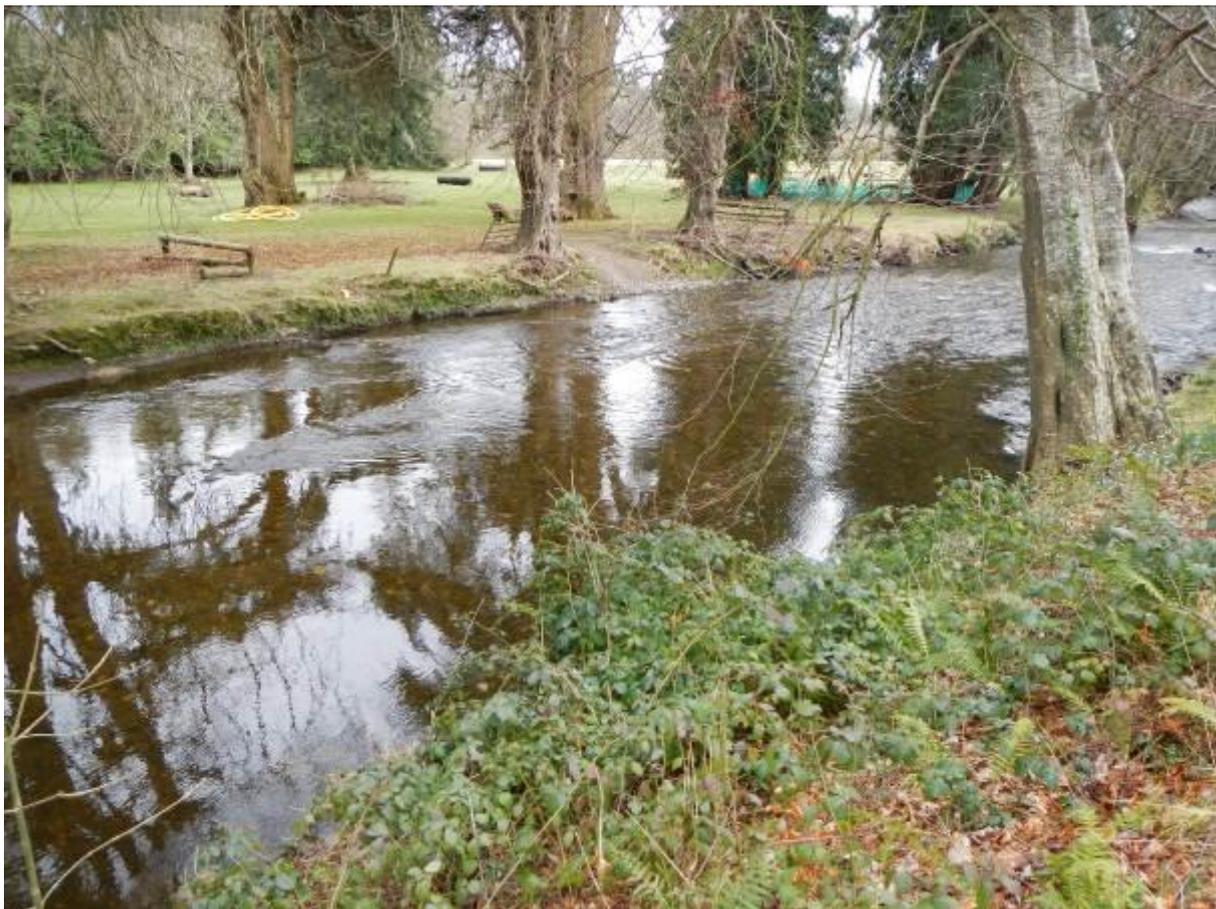
Directly d/s of the erosion, potentially high quality spawning habitat for salmon and sea trout was observed (Fig. 28). However, the quality of this habitat and the survival of any eggs that are laid within the gravels will be seriously compromised by the u/s erosion and inputs of soil/fine sediment. Fine sediment deposited over gravels blocks the spaces between them, not only reducing the habitat niches available for beneficial invertebrate species but also inhibiting the through-flow of water within the gravels that is vital to oxygenate incubating fish eggs.

Figure 28. Potentially high quality spawning habitat that could be greatly improved by excluding livestock from the riverbank to increase vegetation cover.

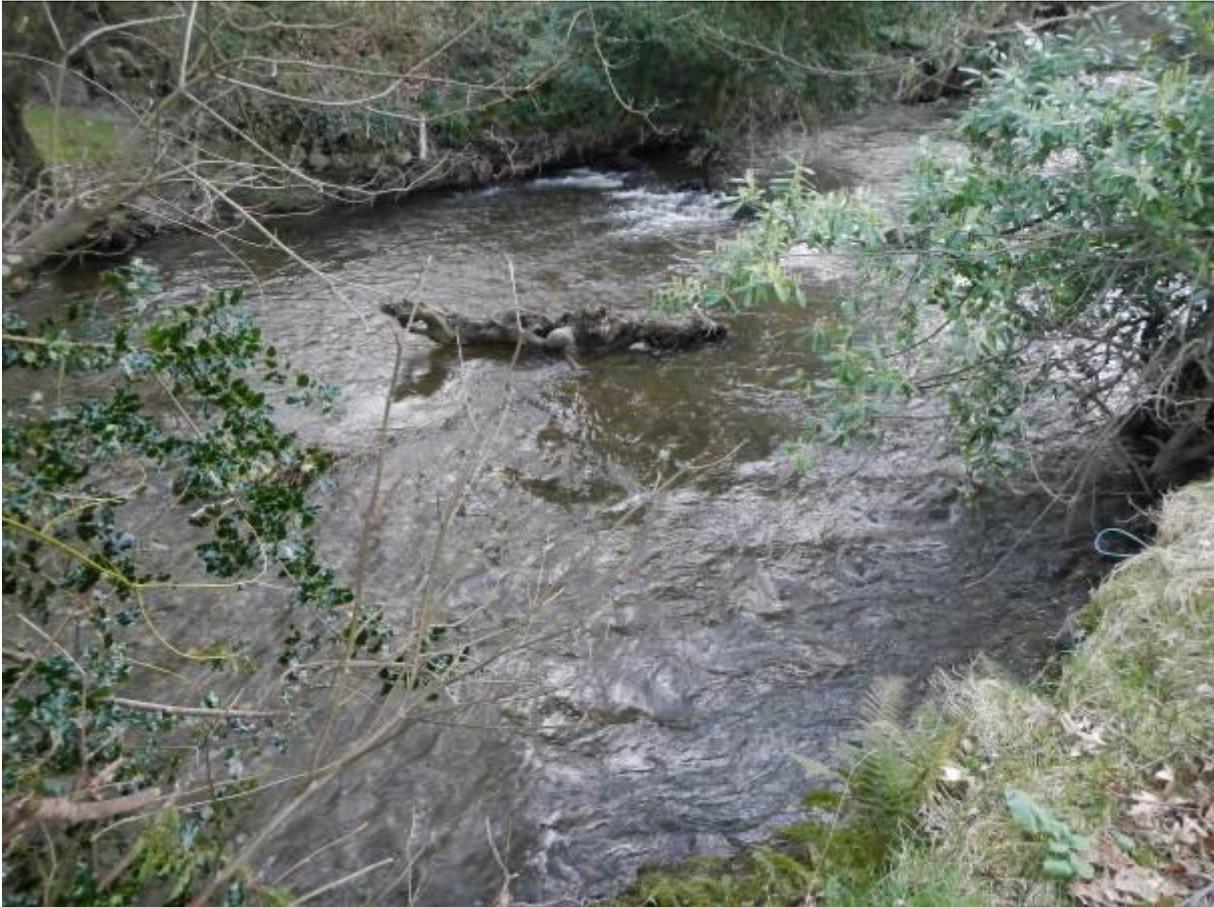
Where livestock access is reduced, low-level and trailing cover greatly enhance habitat quality (Fig. 29). The remains of a suspected small weir is also present but in its dilapidated state it poses no real issues.

Figure 28. Improved cover availability greatly enhances this area. The remains of a small boulder weir (right of shot) poses no real impact.

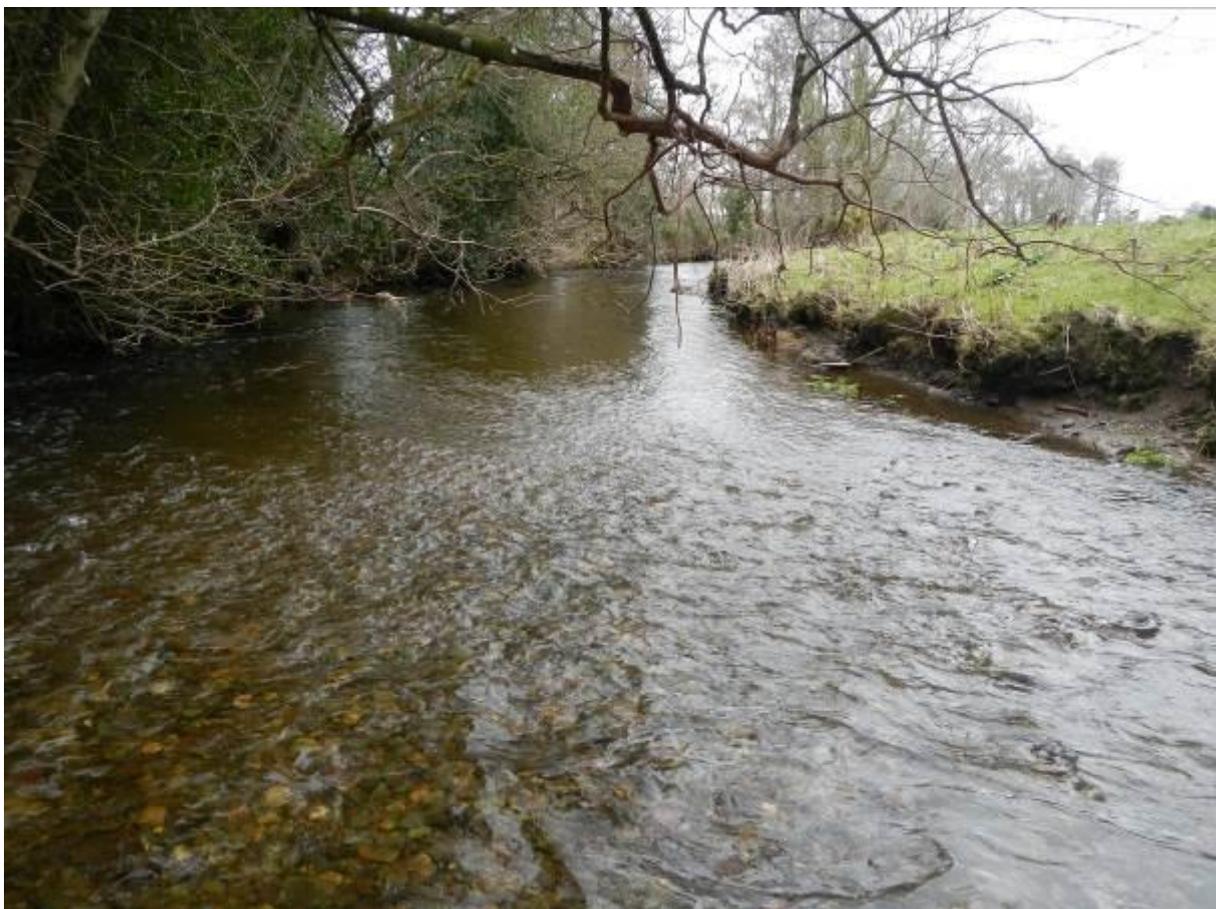
Figure 29. A pool providing good quality habitat; however, a lack of stability within the RB will ultimately lead to widening and shallowing over time as the reduced flow energy leads to deposition of bed material within the pool.

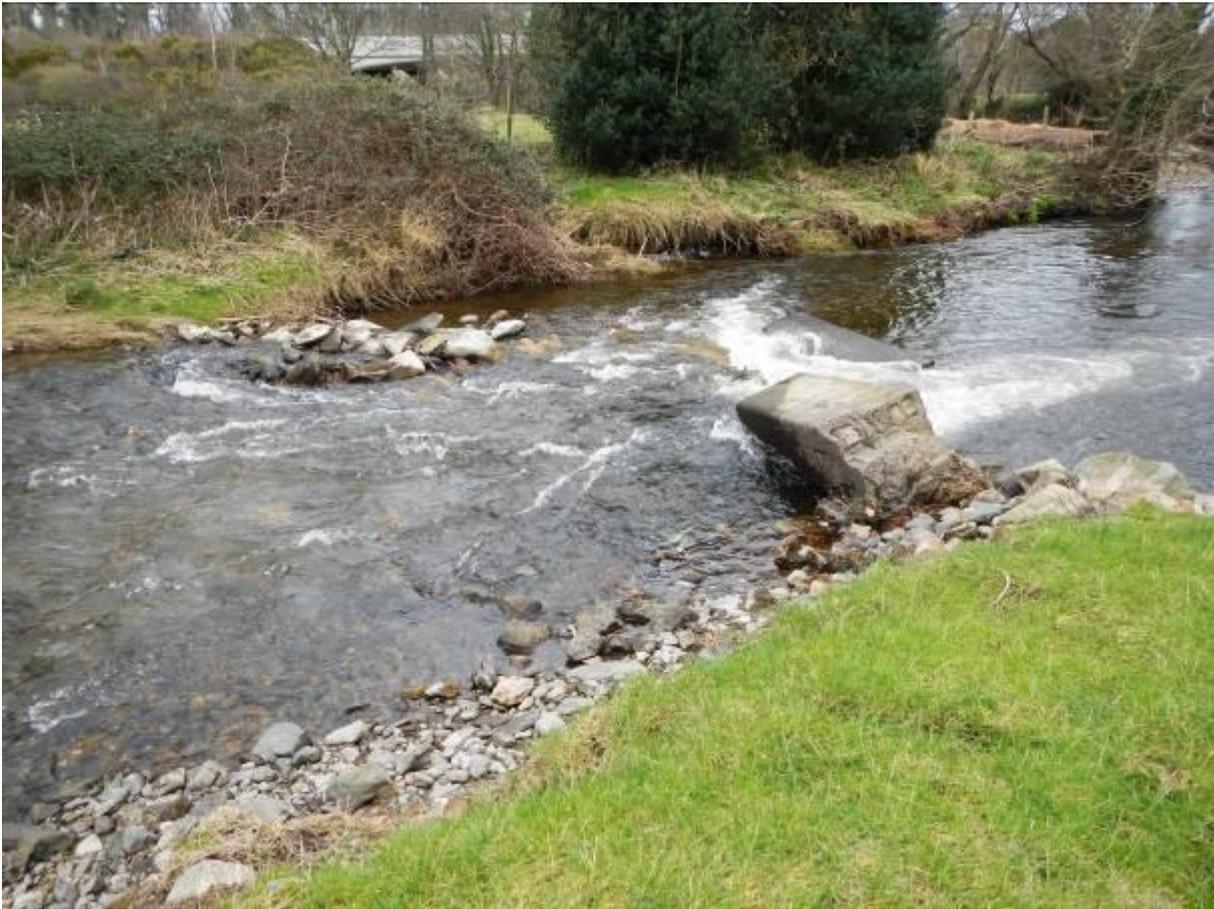
Two large d/s facing groyne structures that have now become dislodged have exacerbated erosion of both banks around and d/s of their original location. This is because, while they funnel flow into the centre of the channel at low flows, higher flows passing over them are diverted outwards, towards the bank. Similarly, u/s facing groynes tend to deflect water away from the bank as they are overtopped (see Fig. 31). Groynes are only usually of value on heavily altered or degraded channels as on more natural river channels (like most of the Vartry), it is far better to work with natural structures and process. Removing the old groyne structures from the

Figure 30. Collapsed d/s paired deflector that would have focussed flows to the centre of the channel at low water but deflected any high flows that overtopped the structure into the banks, causing erosion and widening the channel.

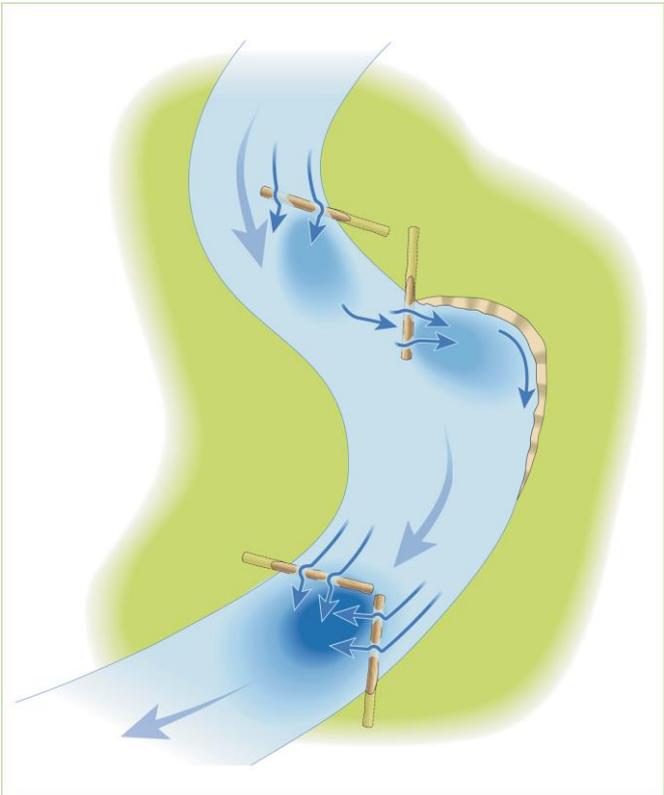
Figure 31. Several flow deflector orientations. Note how the d/s facing deflector sends flows towards the bank when overtopped.

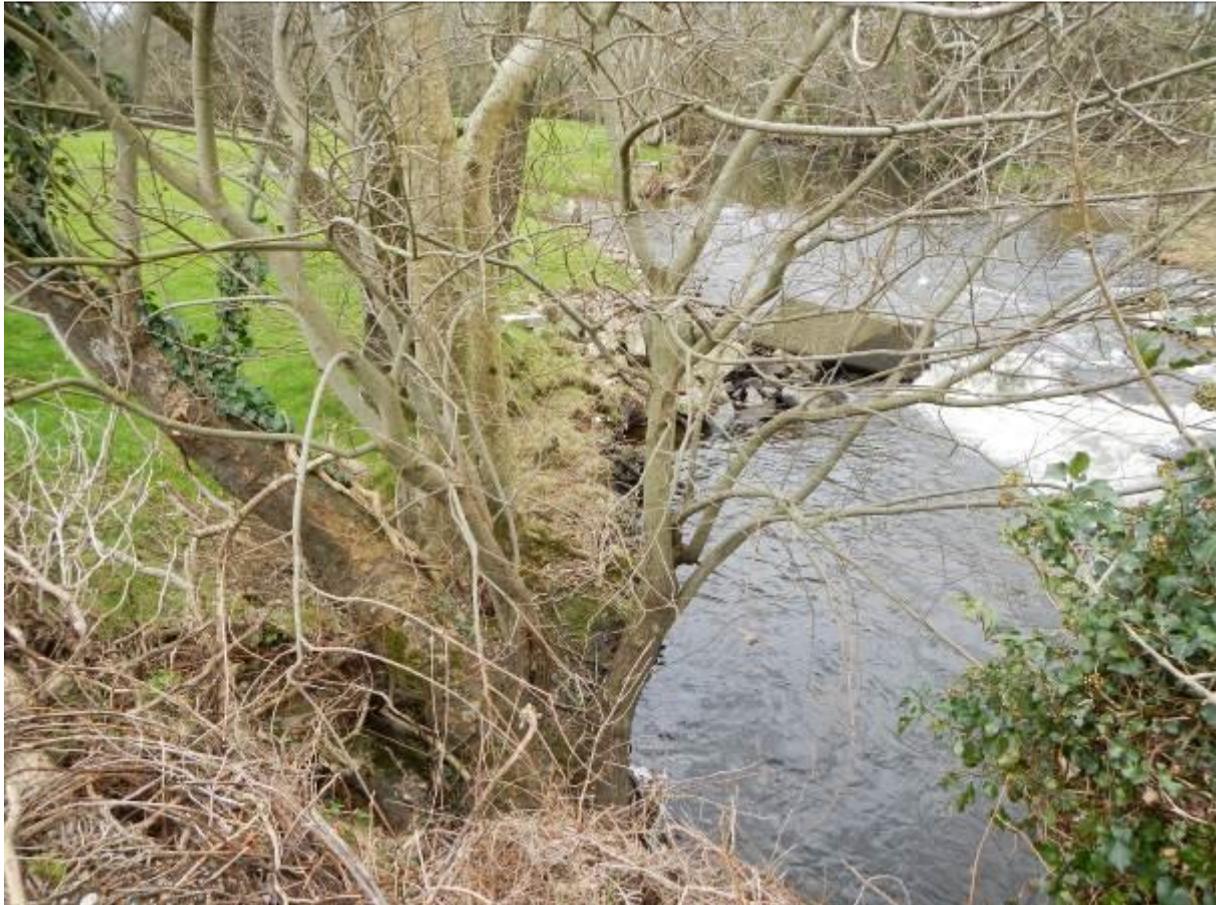
Figure 32. The right hand trunk of the willow tree (centre of shot) could be laid along the bank to provide low-level and trailing cover to the pool.

A bankside willow (*Salix* sp.) d/s of the groynes could be beneficially laid along the bank (as you would lay shrubs within a hedge) to improve the availability of low cover and improve its ability to hold fish (Fig. 32). The convention is to lay willows at 45° or less angle facing d/s, so as not to trap debris and to reduce the flow pressure acting upon them. However, in this instance, owing to the tree's location and orientation of its branches, the technique can only be employed by laying the branch u/s along the bank where it could be secured to a fence (or live willow) post with hessian rope, towards the tip end.

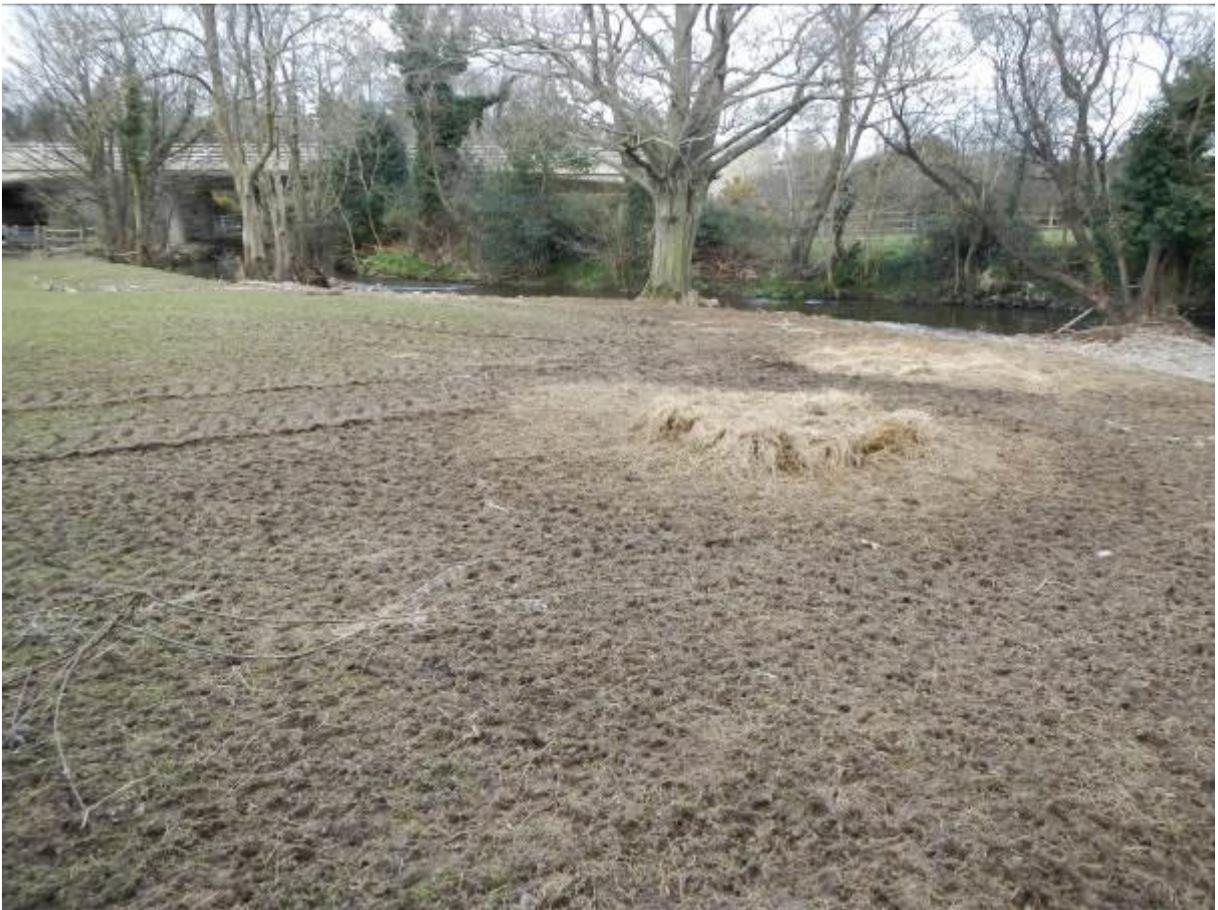
Figure 33. Locating a feeder directly adjacent to the river is leading to excessive bank erosion and sediment and faecal matter entering the watercourse.

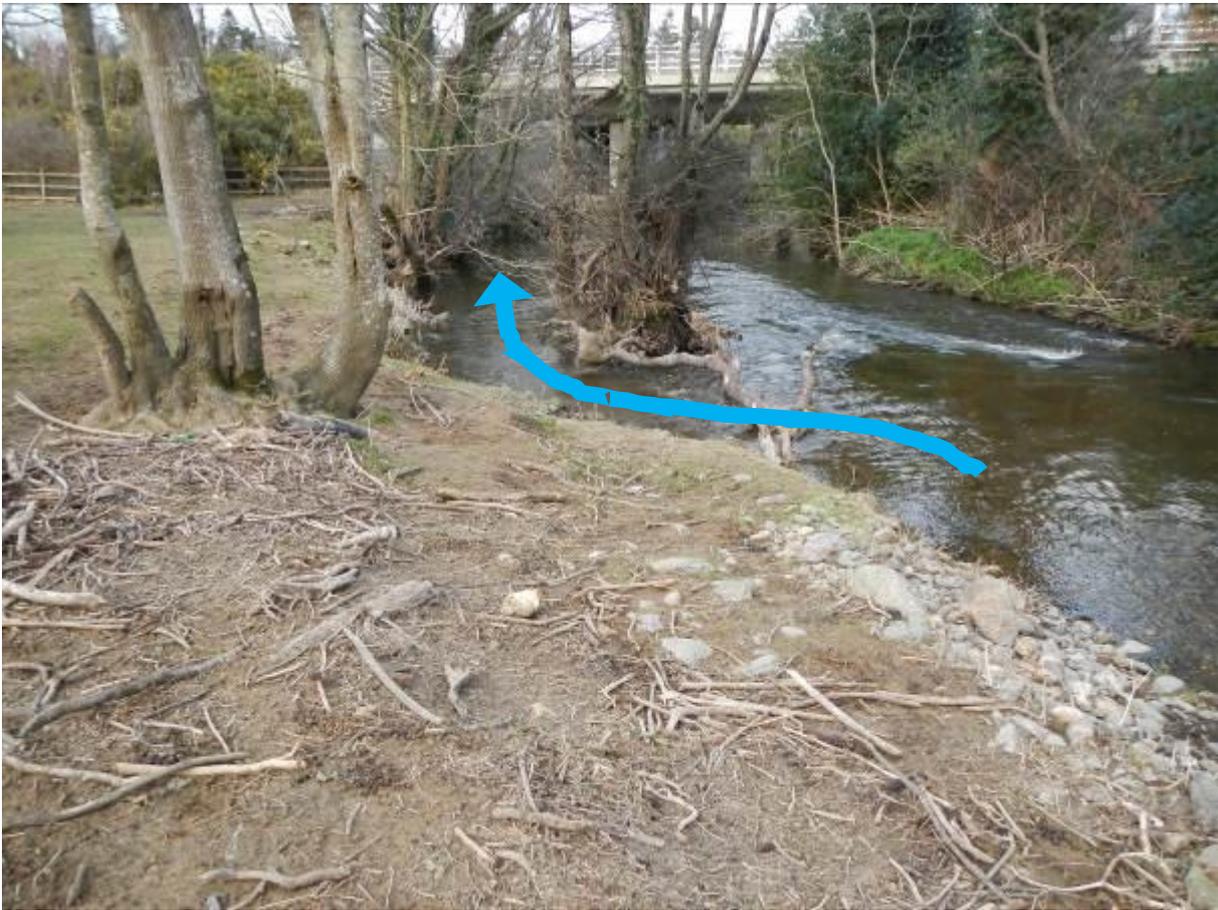
Figure 34. Focussing grazing pressure and poaching along the river bank also further destabilises the bank and makes bankside trees more prone to wash-out. Note how one tree has already been out-flanked by the river.

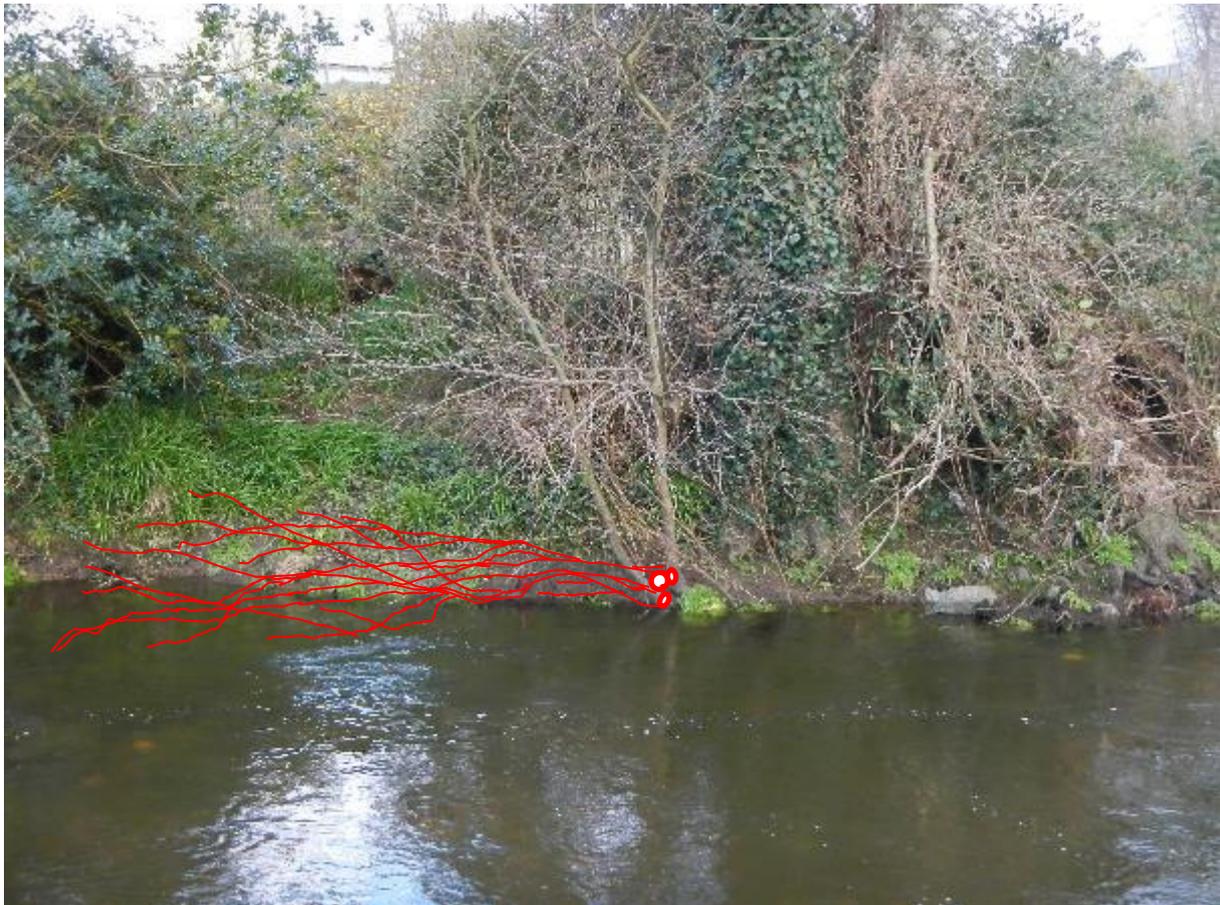
Figure 35. Occasional bankside shrubs could be laid to create additional low cover, as depicted by the red outline.

In locations throughout the river, small bankside shrubs present an opportunity to increase low cover through laying, particularly along the non-fishing banks (Fig. 35). As described previously, this technique works well with willows, which may even take root from any branches touching the ground or water, but can be applied to other pliable species such as hazel (*Corylus avellana*), elm (*Ulmus minor*) and hawthorn (*Crataegus monogyna*). Any tree work, should be done sparingly so as not to create one type of habitat at the expense of another.

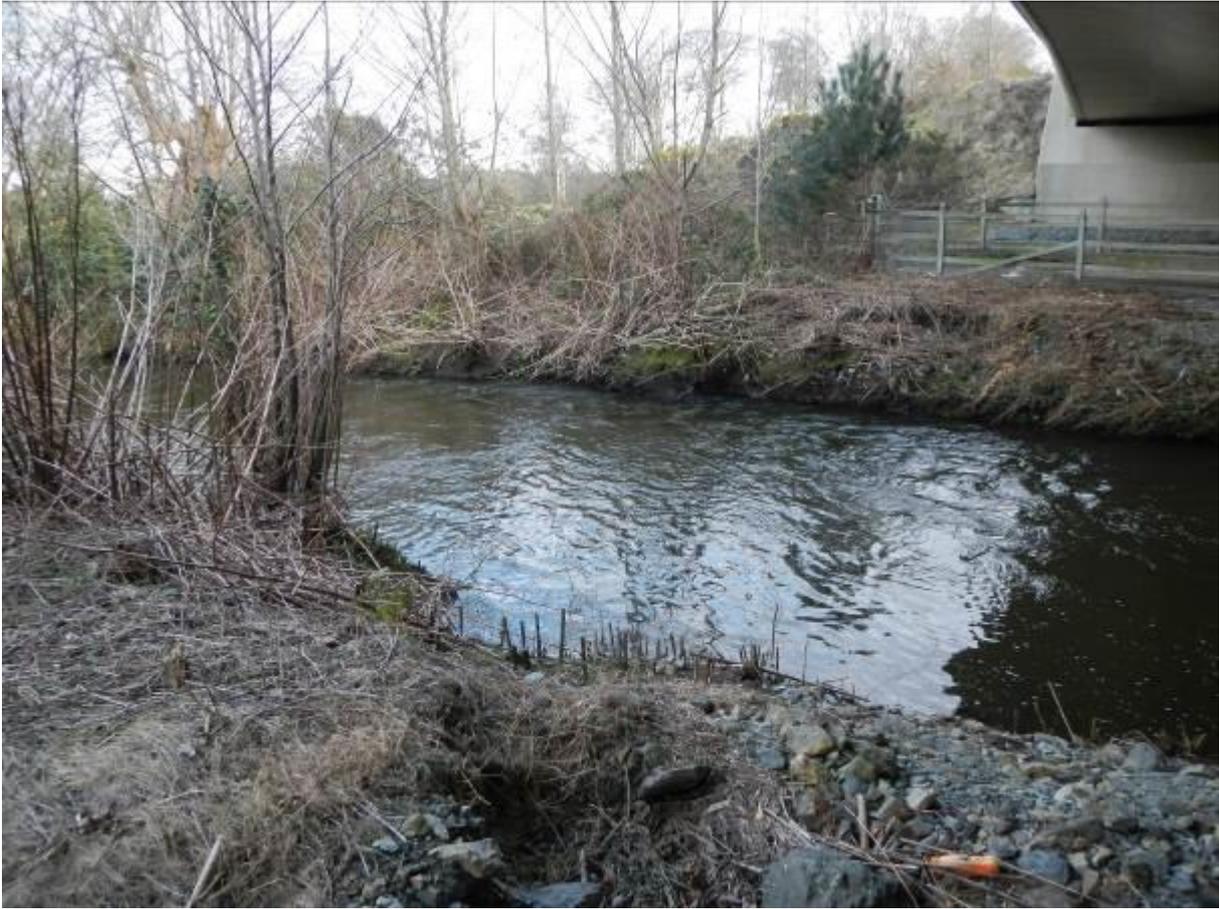
Figure 36. A large area of Japanese knotweed that has been cut, potentially distributing the problem much farther afield.
