Advisory Visit

River Vartry, Co. Wicklow, Ireland

24th & 25th February 2016

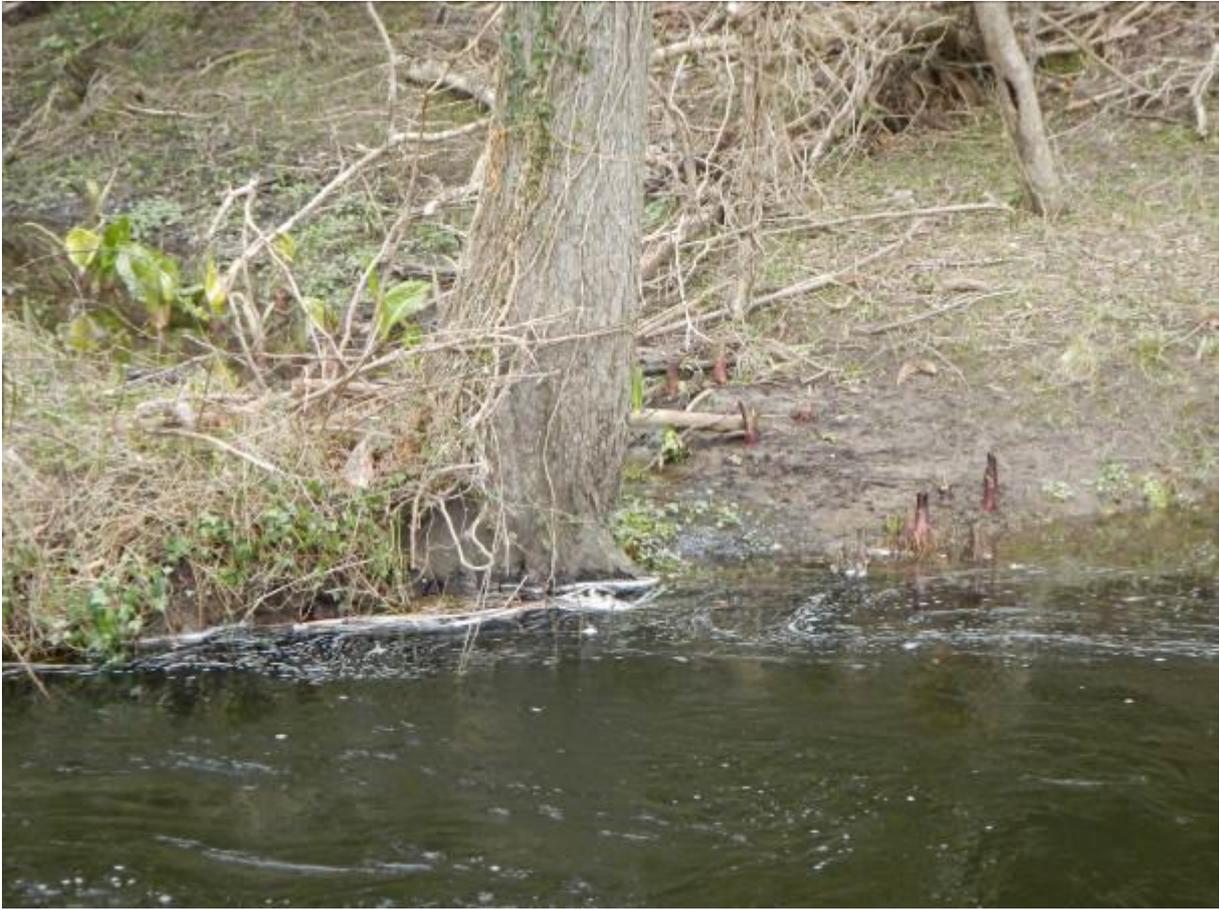
Figure 37. Skunk cabbage to the right (spires emerging along the waterline) and behind a bankside tree (large green and yellowish-green leaves).

The skunk cabbage noted in the area d/s of Rosanna House (around Figure 29), at the bend depicted in Figure 37, and anywhere else it is identified should also be treated. It too is likely to cause further issues by out-competing beneficial native species, if allowed to proliferate.

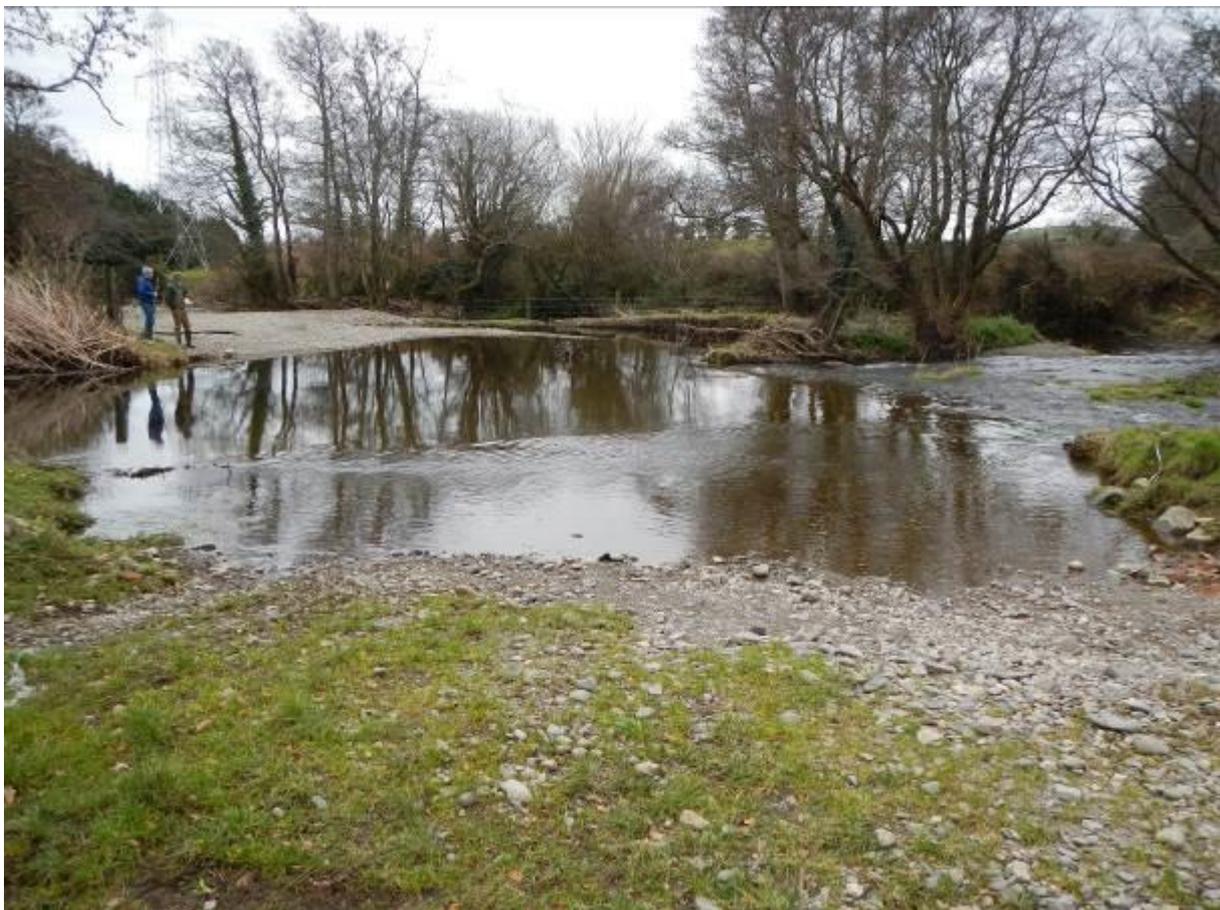
At a fording point, a combination of physical damage and backwash from cattle and vehicles crossing, coupled with cattle poaching and grazing has destabilised the bank and led to major erosion that now threatens both the ford and a peninsula of land d/s, as the river tries to cut through at high flows (Fig. 38). Rock armouring here is not a suitable solution because the hard structure would simply deflect scour leading to further erosion around the rocks and erosion u/s and d/s of them.

Figure 38. River flowing L-R with erosion at both sides of a fording point. Recent flood flows have exacerbated erosion on the already destabilised far bank and started to cut across the bend.

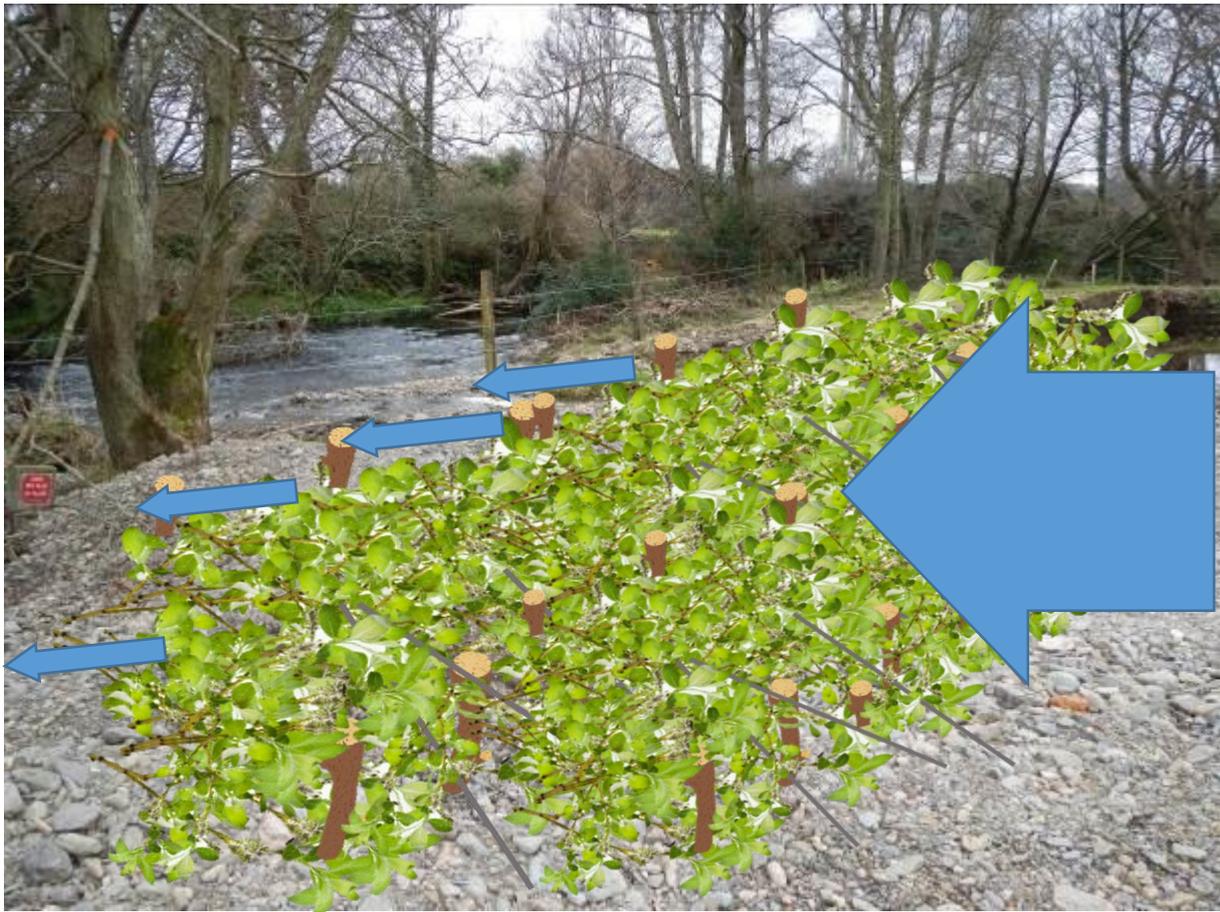
Figure 39. Slowing the transition of water across the bend and restricting its egress at the far side would greatly reduce the flow energy across the bend, reducing erosion and causing any bed material to be deposited there, turning it from an area of scour to an area of deposition. This would also encourage flows to follow the original channel course as the path of least resistance.

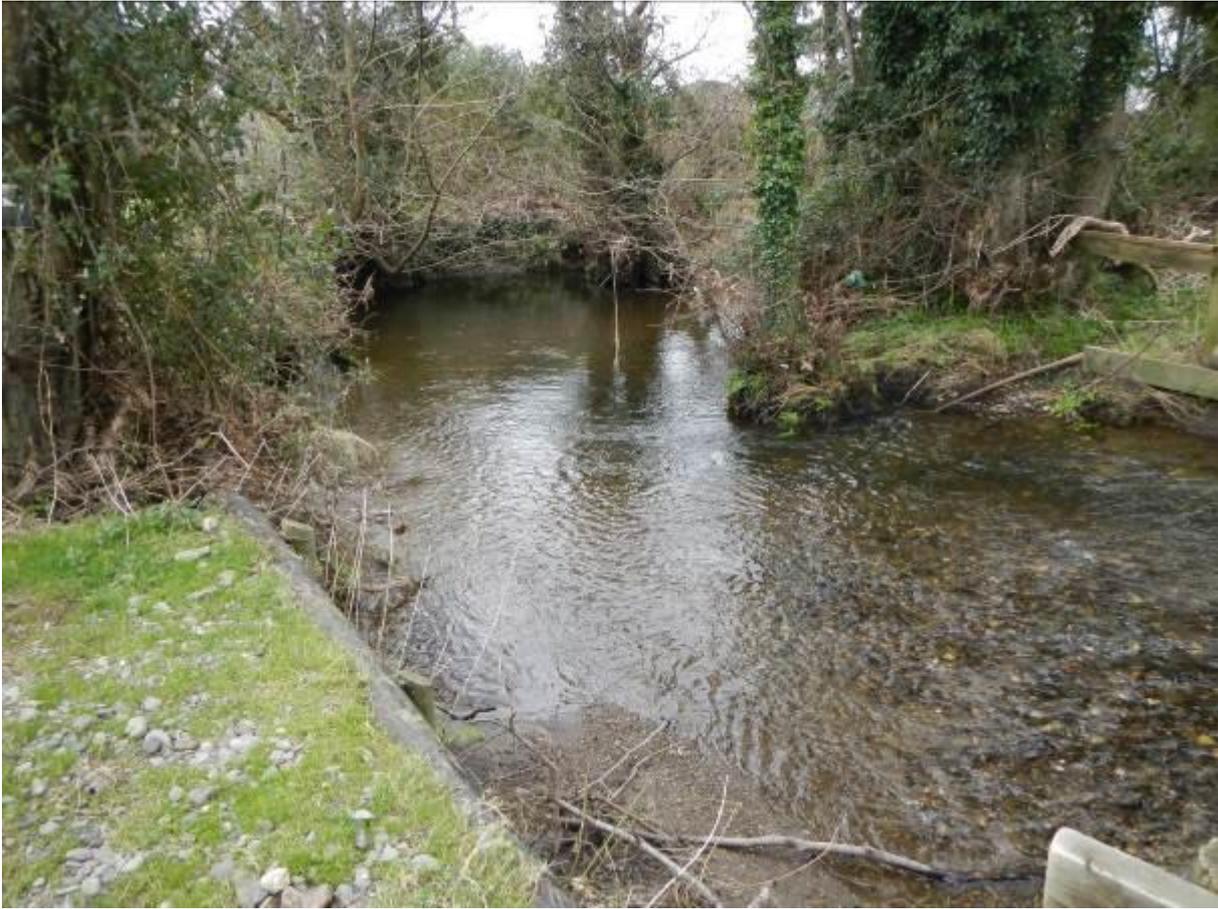
A small side channel around an island provides some valuable habitat diversity (Fig. 40). The reduced flows within the channel has facilitated deposition of finer gravel substrate than is available in the main channel. This area offers habitat for aquatic invertebrates and also, potentially, spawning substrate and habitat for smaller salmonids. The notable sediment inputs upstream will inevitably degrade the quality of this habitat which is yet another reason to increase bank stability and reduce bank erosion.

Figure 40. Valuable habitat diversity provided by a small side-channel.

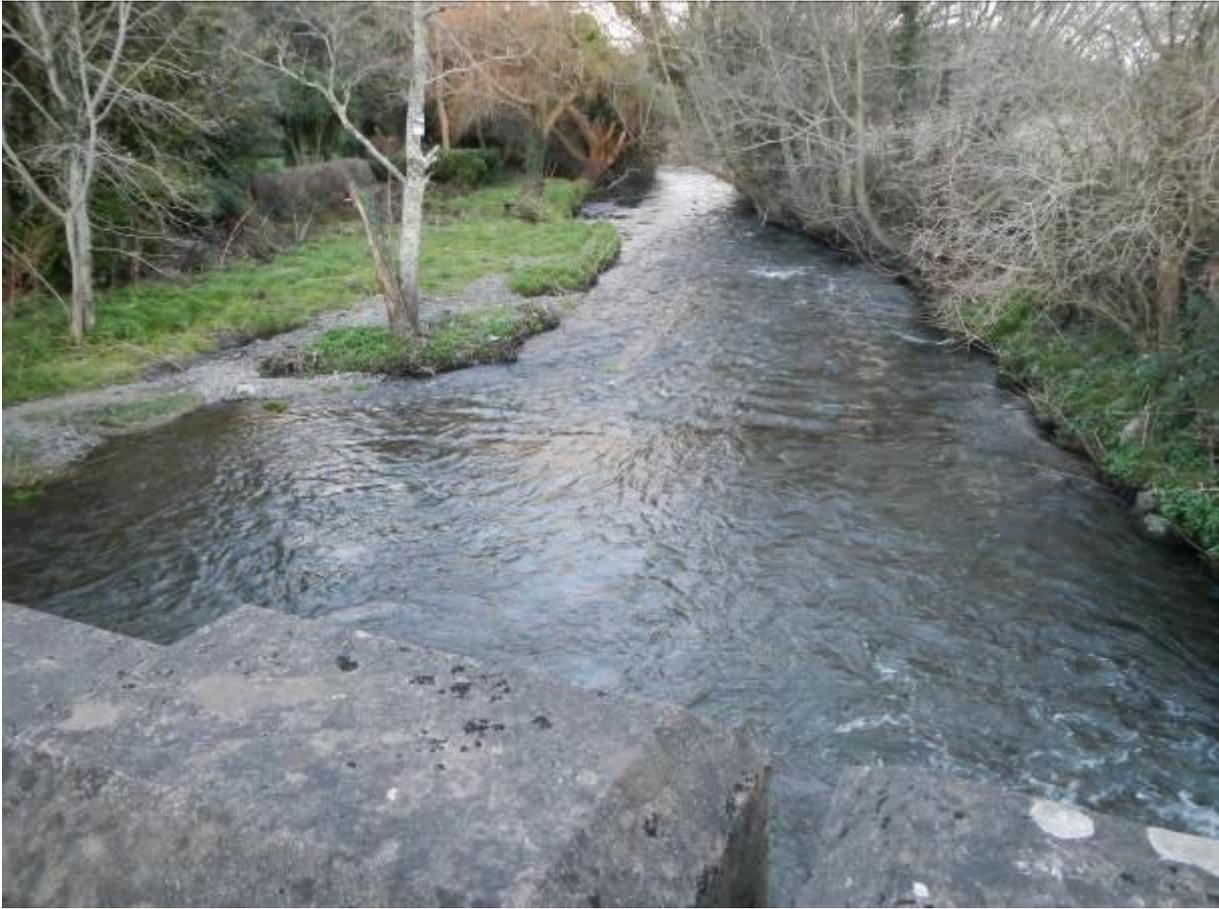
Newrath Bridge demarks the current d/s limit of VACC sole occupancy of the river, with other anglers having access from that point and d/s. The section immediately d/s (Fig. 41) is the location that the IFI surveys are undertaken and that generates high numbers of salmon parr (higher for salmon than trout). While the habitat there is of reasonable quality for juvenile salmonids, it is not completely representative of the whole river, particularly when considering the inaccessible low gradient upper section (u/s of the impassable falls), the steep gorge, and the notably impounded Ashford section.

Figure 41. Newrath Bridge – the d/s limit of VACC sole occupancy for angling and the location of fisheries surveys.

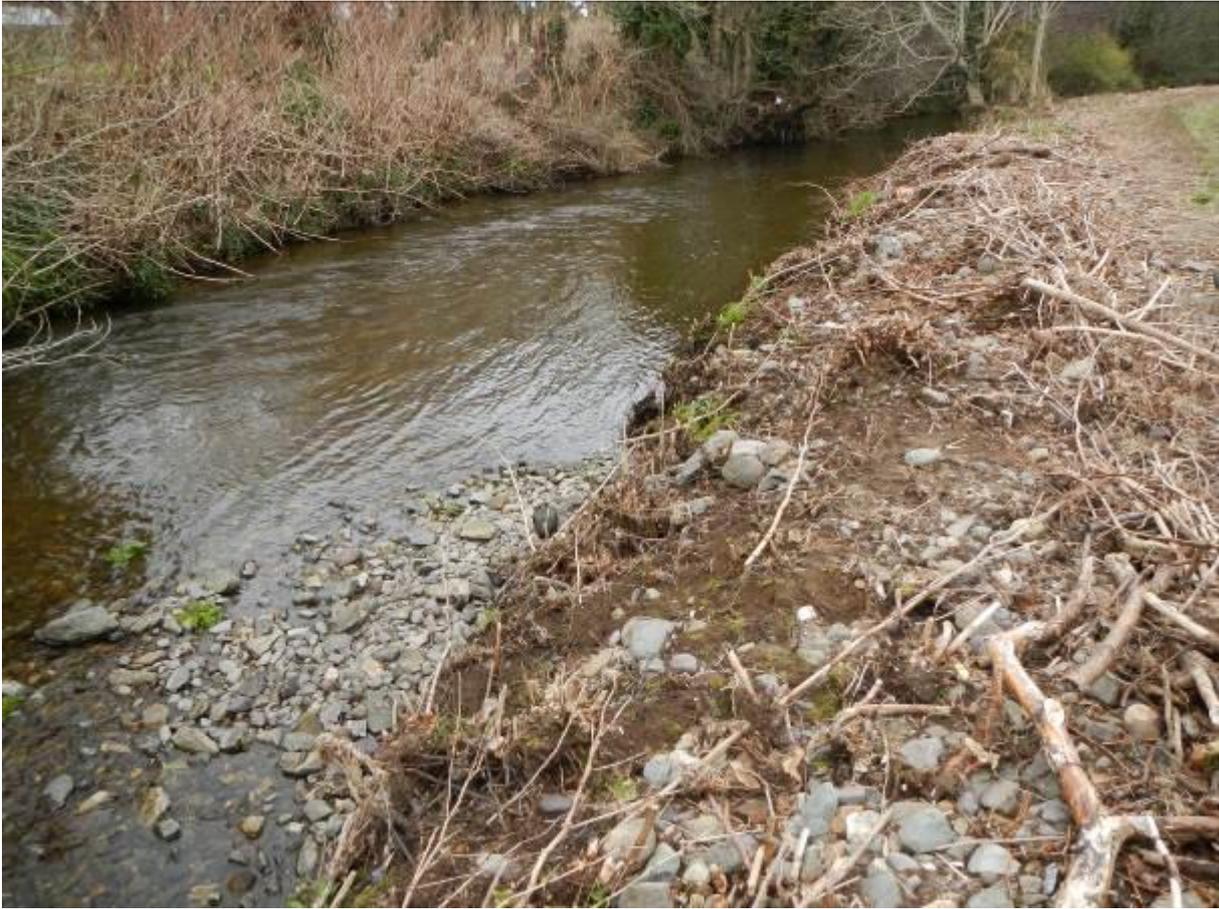
Figure 42. The knotweed issue progressively increases d/s, with large stands on both banks and associated bank destabilisation issues.

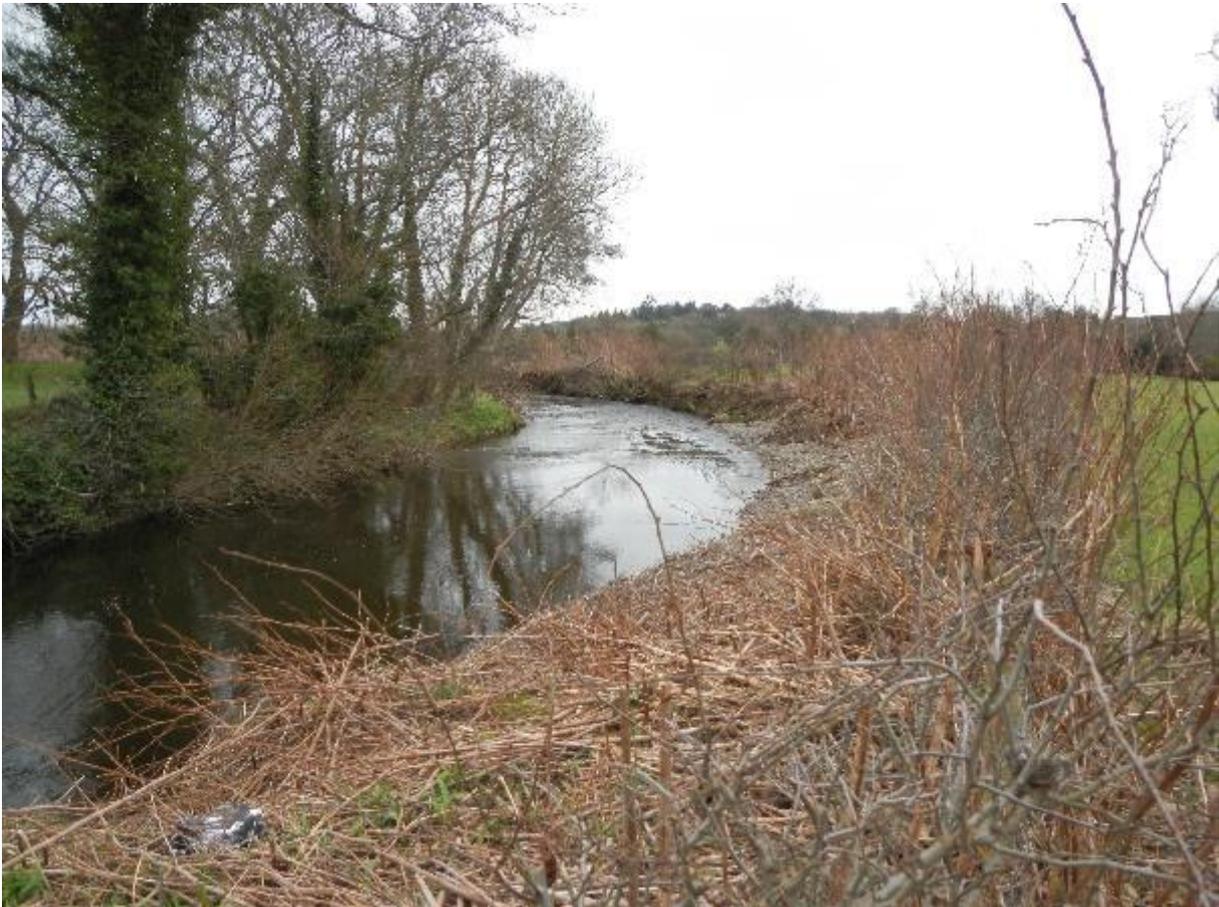
Figure 43. A near monoculture of knotweed exists along the river bank in many areas.

If the knotweed issue can be controlled, it is recommended that a buffer fence be installed along all grazed river bank sections to exclude livestock. This will then allow the development of more extensive vegetation that will provide improvements to both habitat and bank stability.

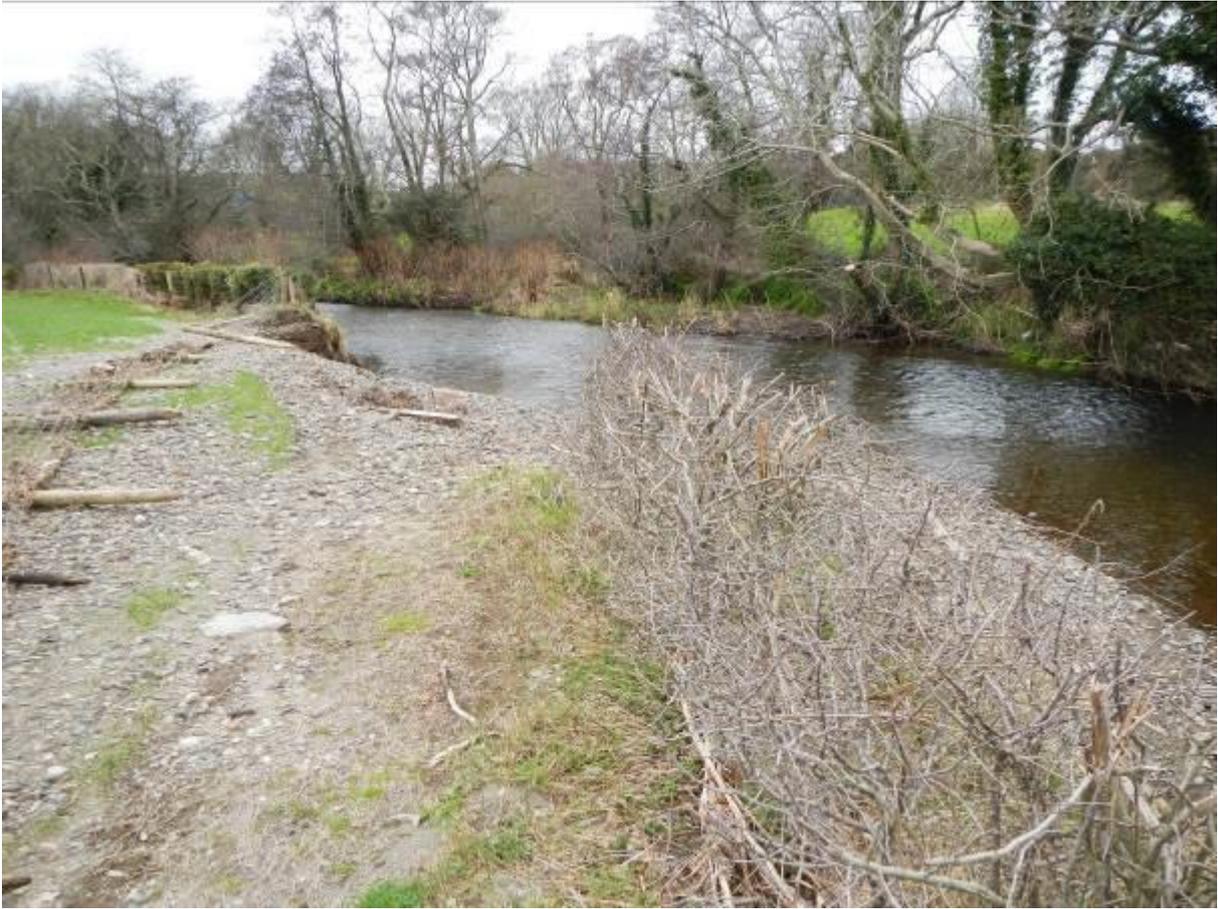
Figure 44. Erosion on the inside of a bend, an issue that only generally occurs where something has first reduced the stability of the bank.

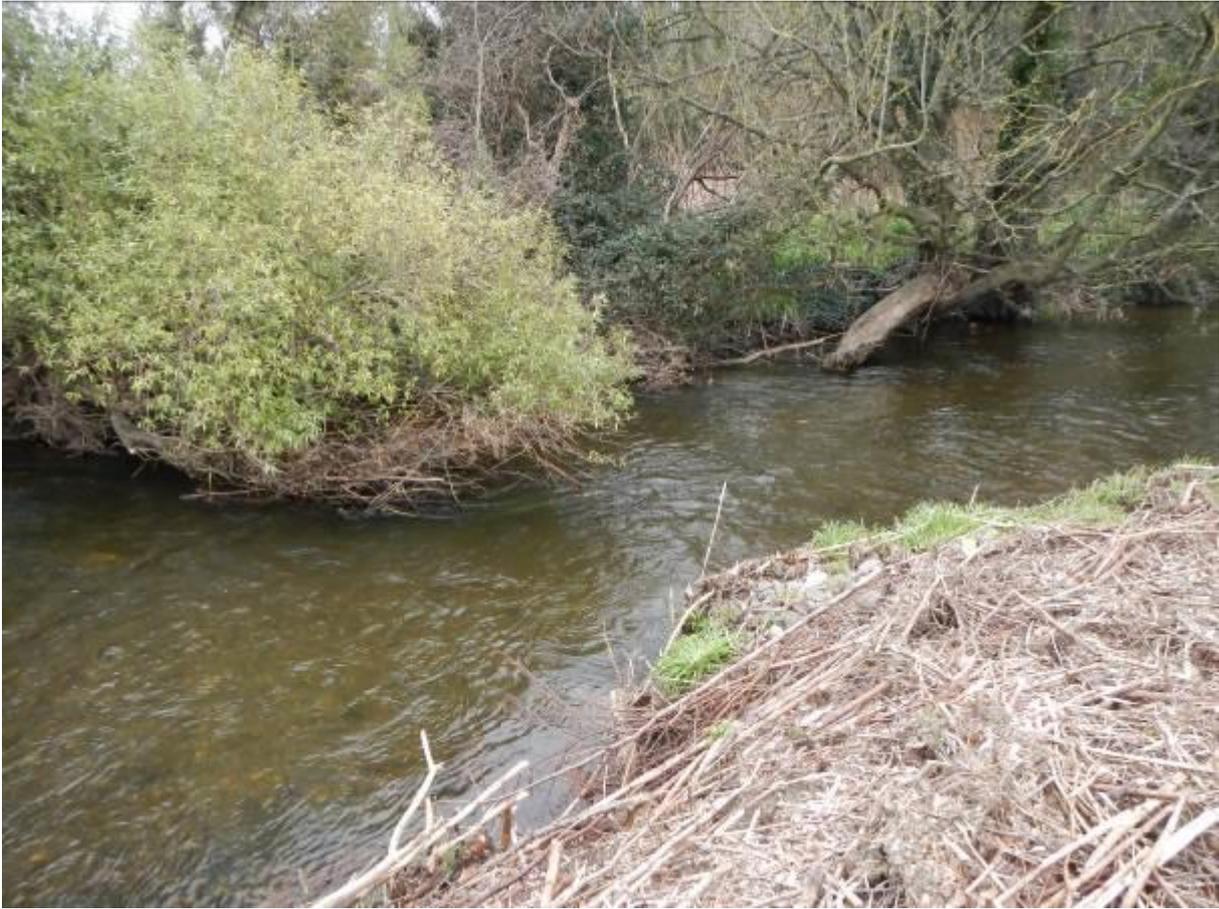
In areas where the knotweed is not yet so extensive, some high quality habitat exists, suitable for both resident trout and as holding water for migratory salmonids (Fig. 45). The overhanging trees and trailing branches provide vital cover, but also sanctuary and protection for fish from high flows and predators such as 'poachers' and piscivorous birds like cormorants. Fish can negotiate their way through in-channel structures such as branches and logs far more easily than the birds can.

Figure 45. Trailing branches provide vital cover and shelter for all stages of the salmonid lifecycle. However, flows constricted by the willow will place pressure on the near bank which is destabilised by the knotweed, leading to erosion. This would not be an issue on a naturally vegetated bank.

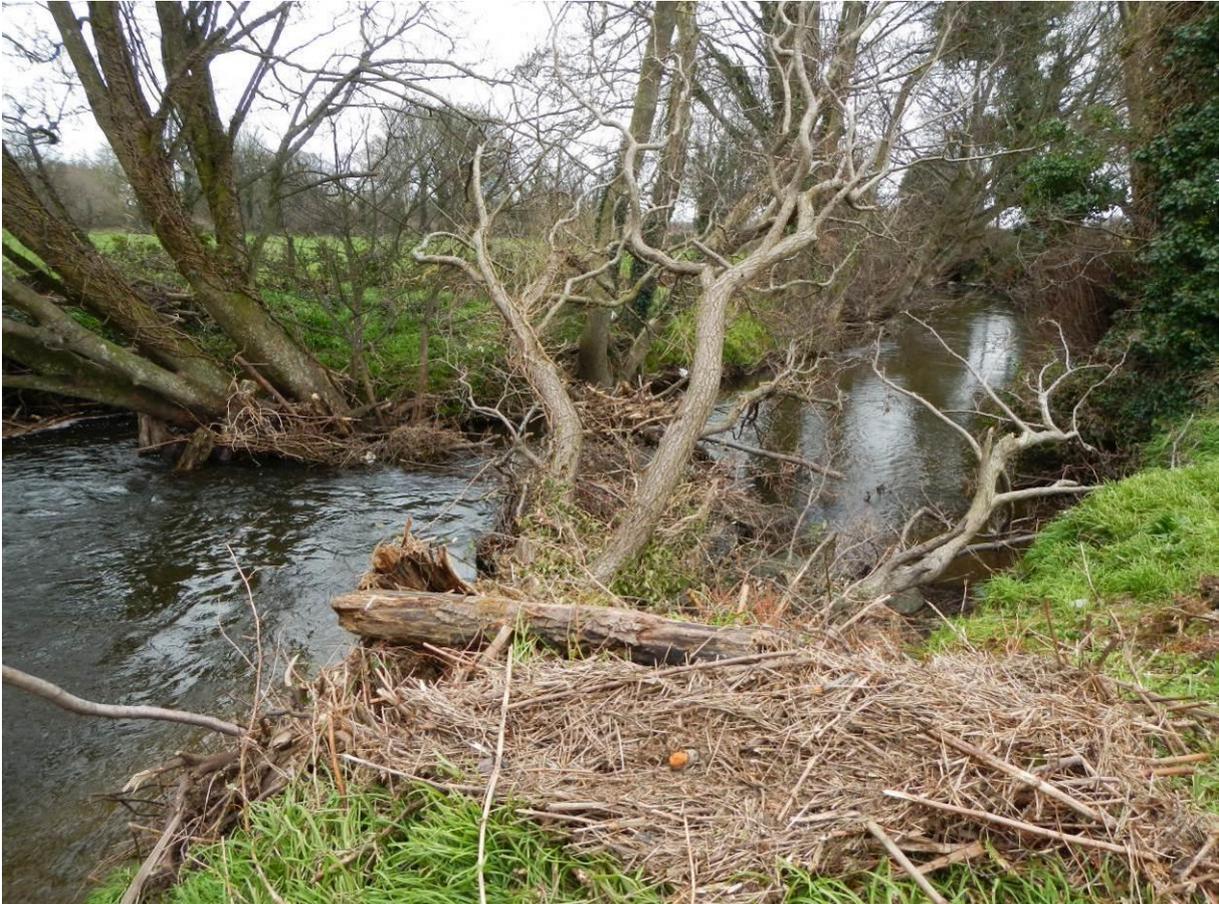
The larger woody material also provides important structure within the channel that focuses flows to enhance scouring of the river bed (Fig. 46). This develops and then maintains pools and sorts gravels by size – the finer material being carried further than the coarse material which drops out of the water column more quickly to form valuable spawning areas and invertebrate habitat.

Figure 46. Large woody material within the channel is again vital for cover, scouring the bed and developing pools and maintaining the bed free from fine sediment.

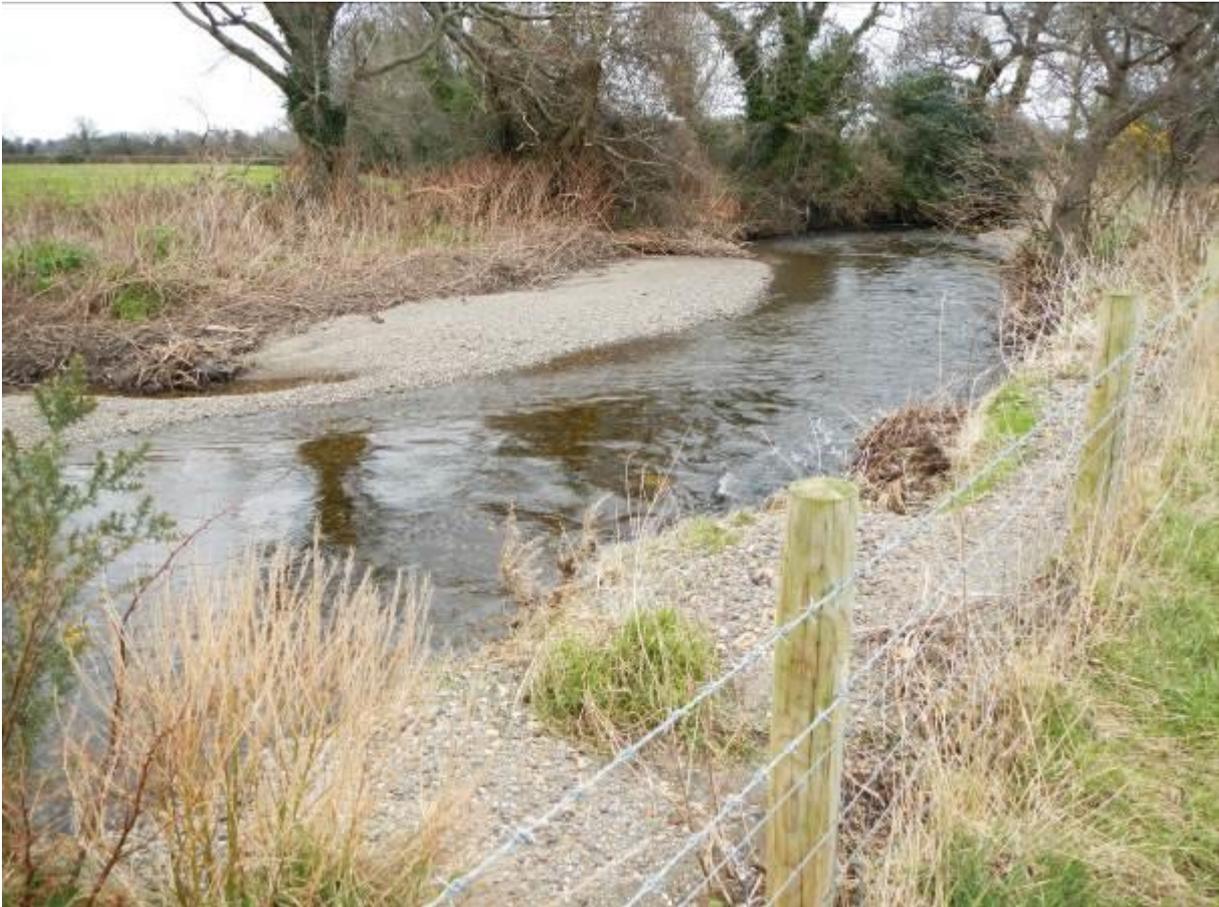
As with most other sections of the river, there is no major issue with gravel supply and distribution but particularly in the section d/s of Newrath Bridge, the river is particularly active in gravel transport. This forms numerous gravel bars and riffles that are valuable salmonid spawning and invertebrate habitat (Fig. 47). However, they are likely to remain more mobile than would naturally occur due to knotweed preventing their colonisation and stabilisation by native vegetation.

Figure 47. There is ample gravel supply throughout the river but its transport is particularly active in the lower reaches.

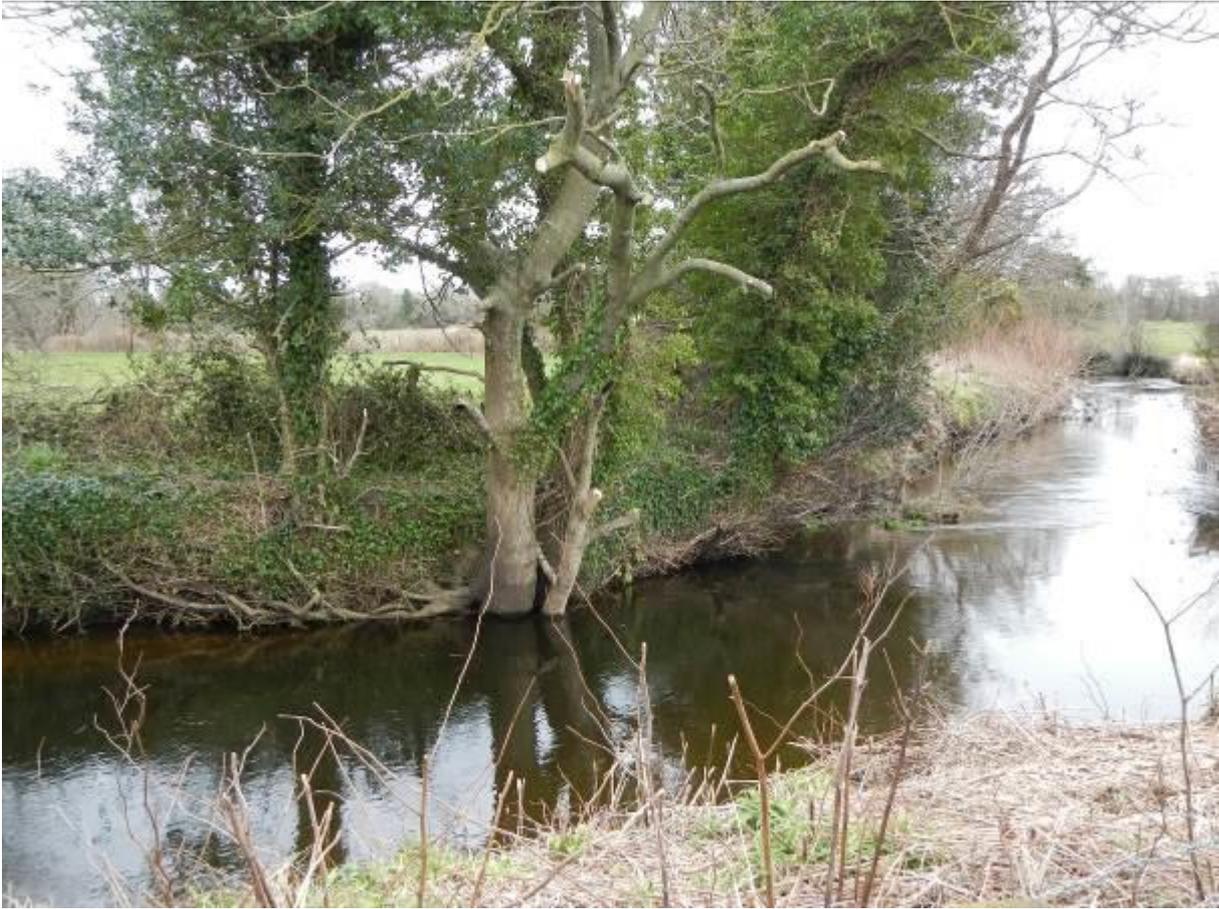
Figure 48. Pruning the lower branches from the ash tree beside this pool has greatly decreased the pools habitat quality and fish holding ability. Access is easier but there will be fewer fish there.

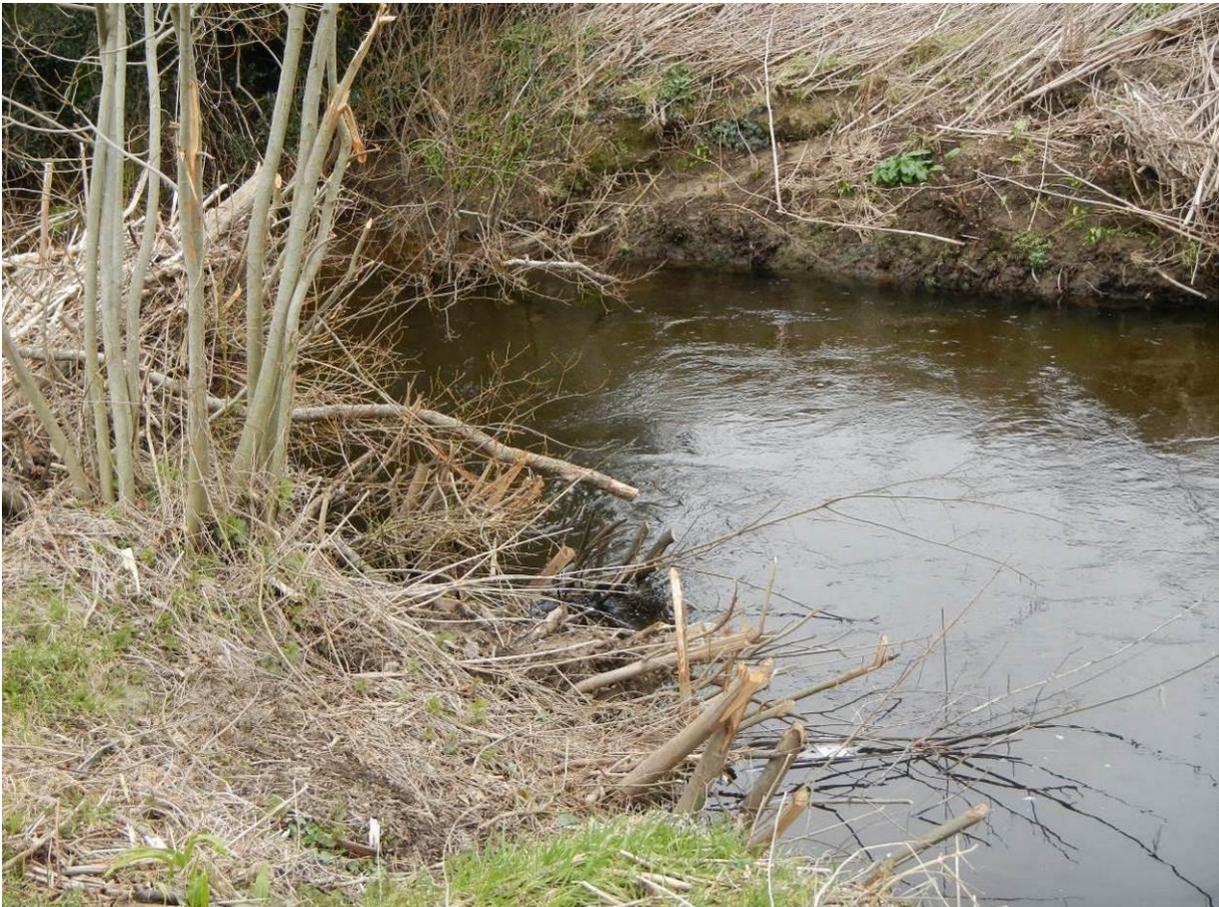
Figure 49. Unsympathetic cutting of valuable in-channel cover habitat.

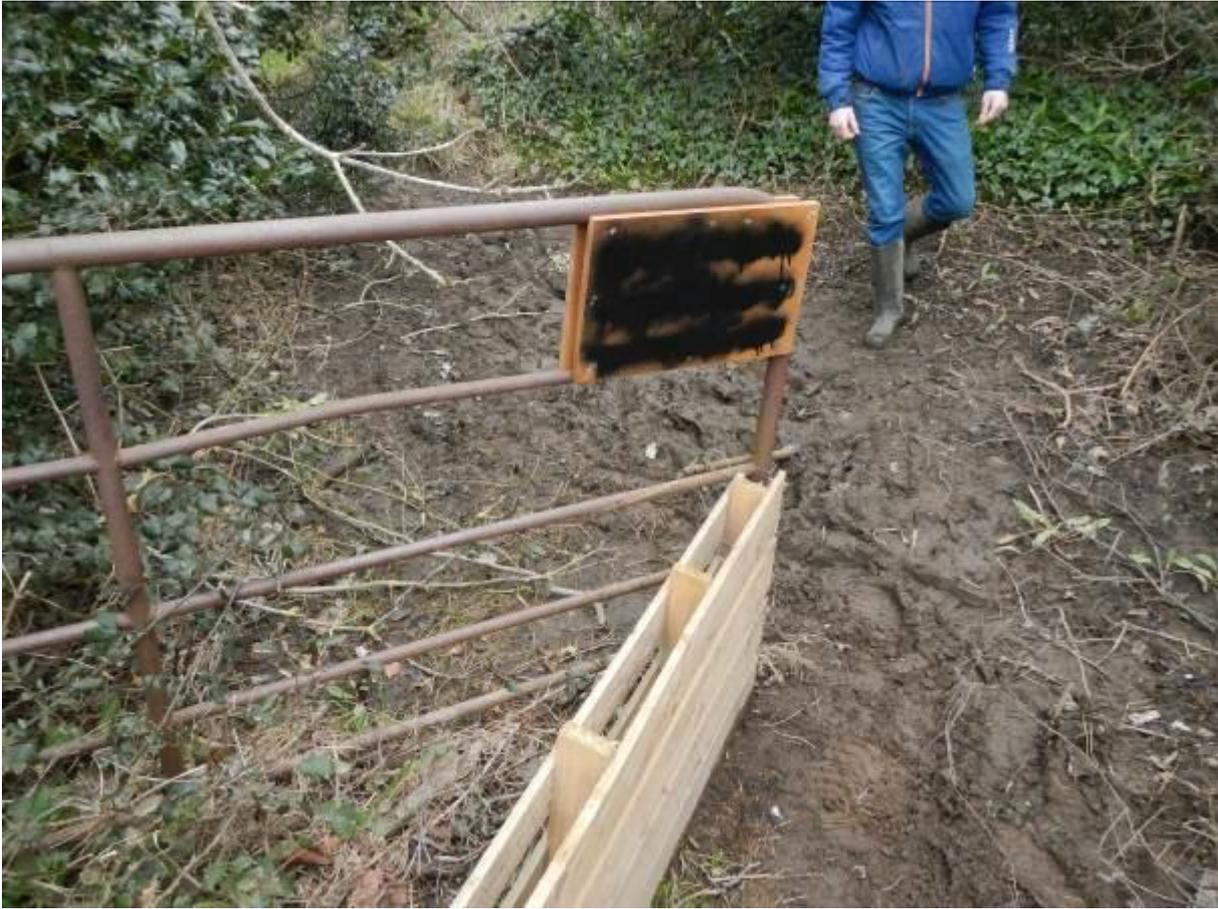
Approximately half way between Newrath Bridge and the Broad Lough, tree and vegetation 'maintenance' by unknown personnel begins to have a significant negative impact upon habitat quality, with the low and trailing branches that provide such high quality habitat in other reaches being cut off to allow easy access to the river (Figs. 48 & 49). This greatly reduces the habitat potential of this area of river. It was also noted that signs were vandalised and hundreds of euros worth of damage has been done to the buffer fencing, with the two top strands of barbed wire having been cut to ease access at all likely fishing spots along the lower reaches of the river.

Figure 50. In addition to inappropriate tree/vegetation pruning, signs have been vandalised suggesting possible contention between users of the area.

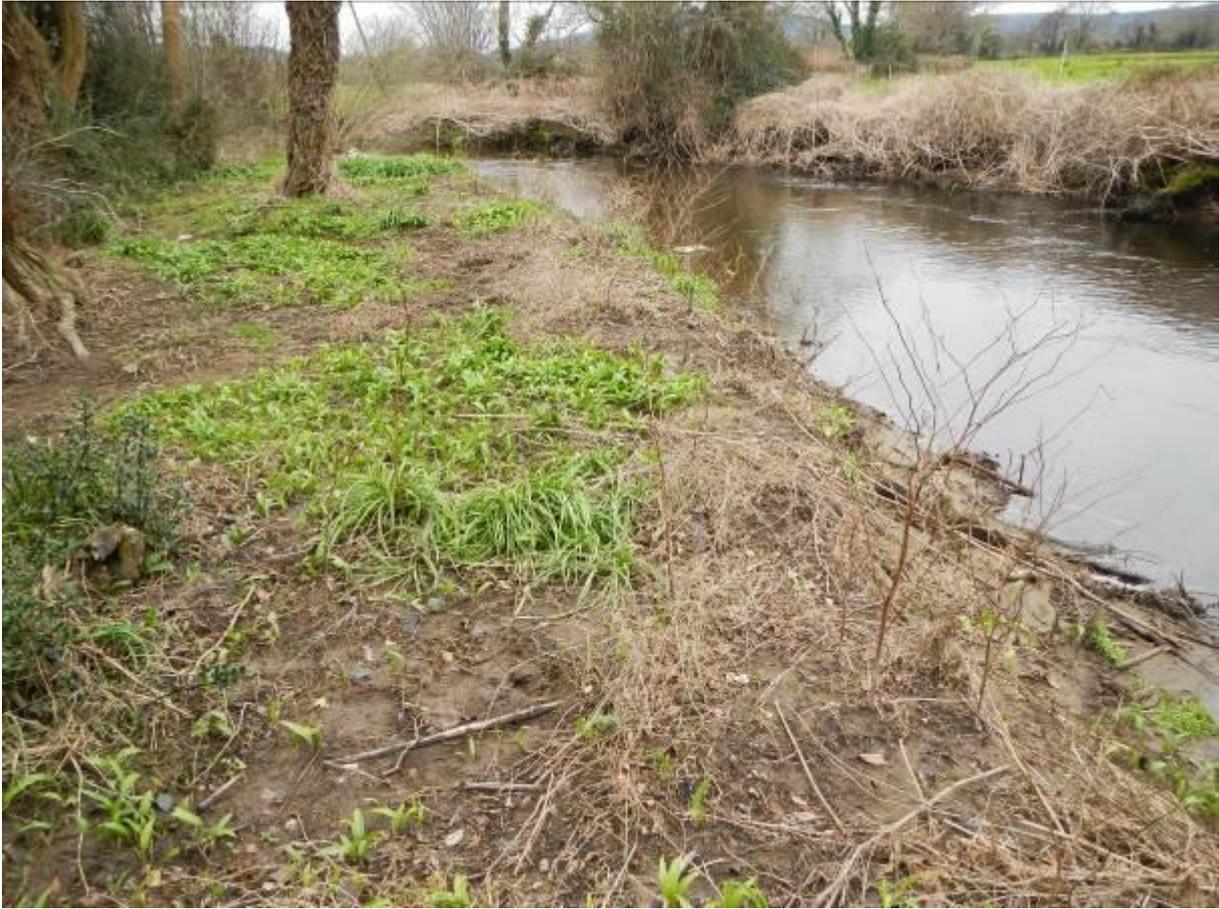
In the very lower reaches of the river, some treatment of the knotweed has been undertaken. This work is to be highly commended and although it has not completely eradicating the plant, the knotweed is being reduced (Figs 51 & 52). When treating knotweed, it is vital not to use a herbicide with a long lasting residual effect as this will prevent the recolonisation of native vegetation that is required to protect the bank and result in equal issues. It is also important to start at the u/s limit of the infestation and this will require a coordinated catchment-scale initiative. While the work on the lower river remains very valid, it will be an ongoing battle to maintain it free of knotweed that is recolonising from sources u/s.

Figure 51. Post treatment of knotweed, some native vegetation is beginning to recolonise.

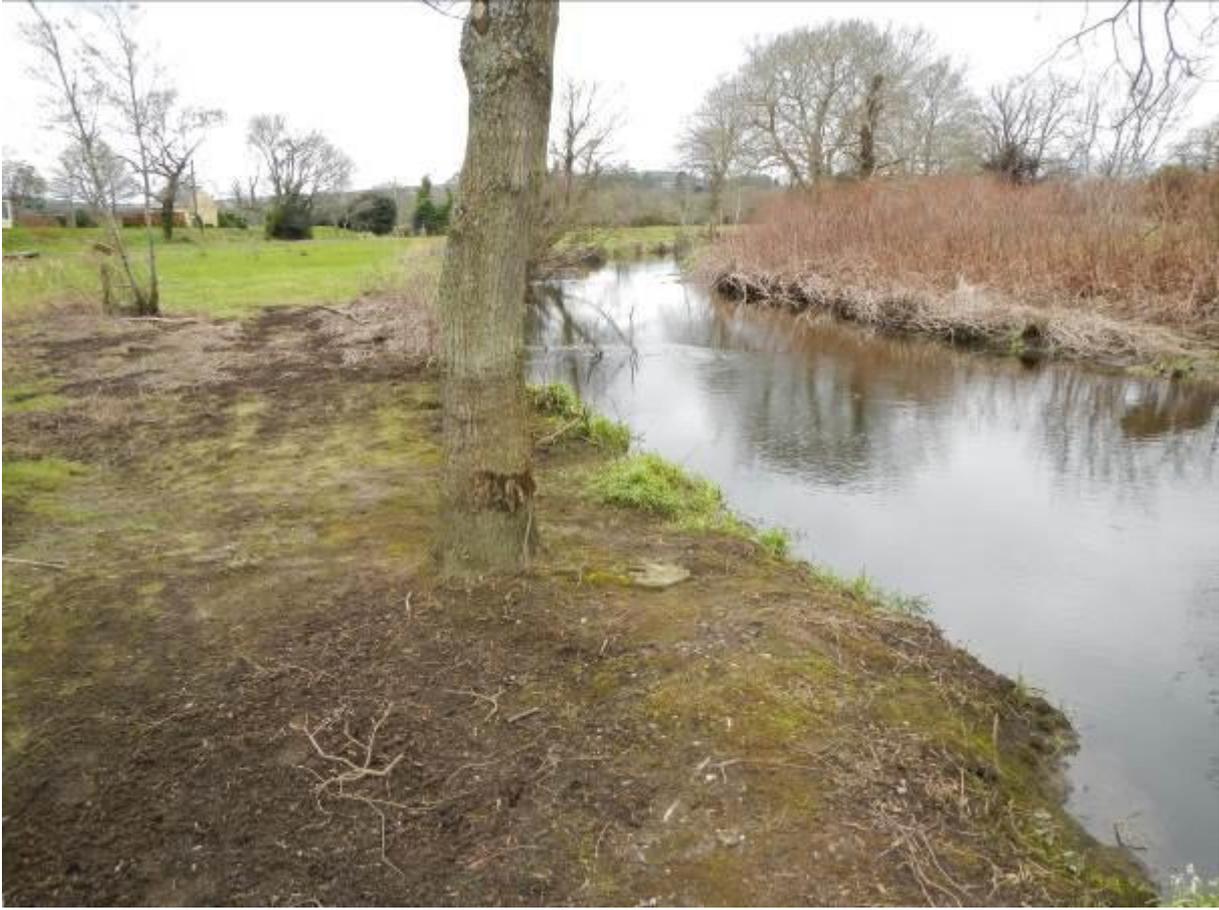
Figure 52. Post treatment of knotweed and some areas of bank remain bare. It would be beneficial to reseed here with a locally native grass and/or wildflower mix to protect the bank. Note the dense stand of knotweed still present on the untreated far bank.

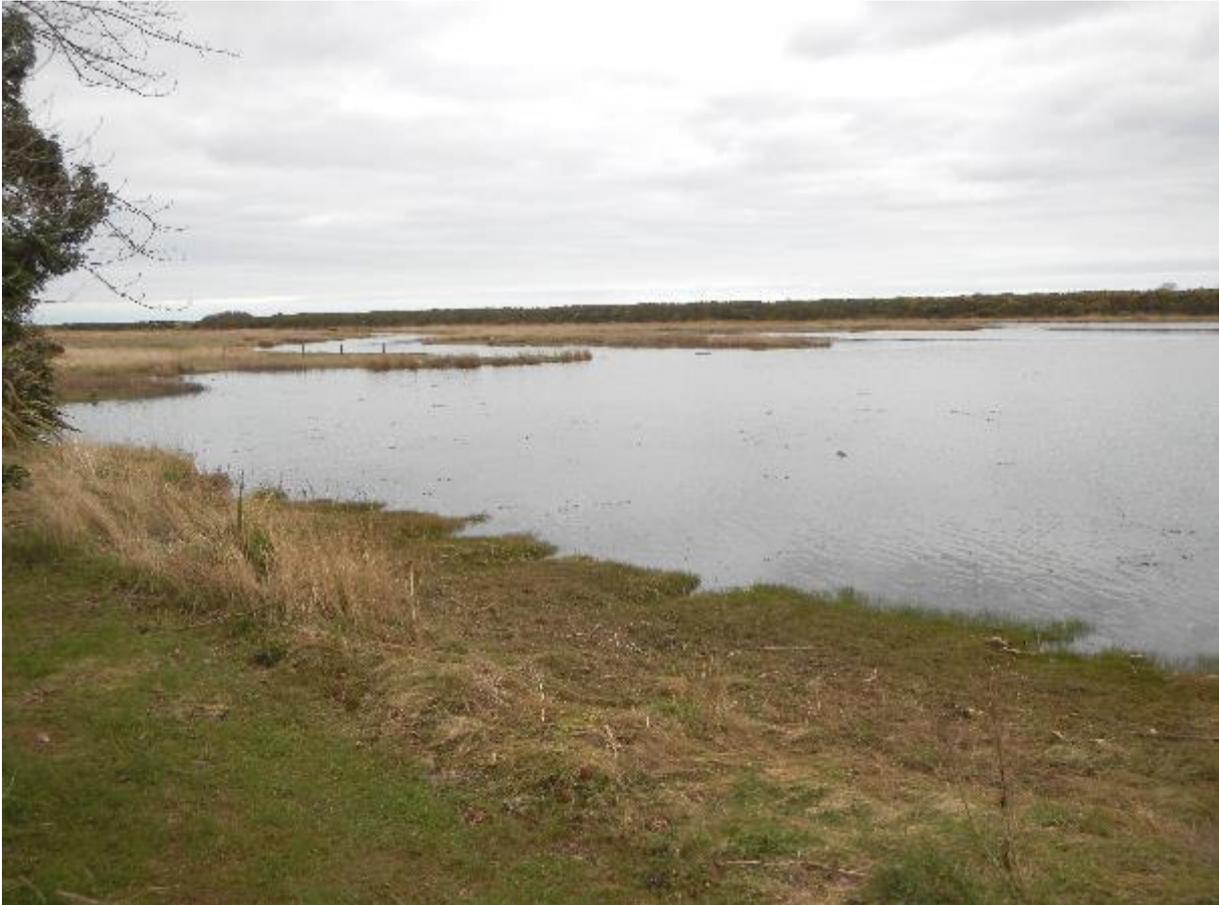
At its d/s extent, the River Vartry discharges into Broad Lough, an extensive tidal lough that offers a further diversification of habitat on the Vartry system and provides a buffer between riverine and marine habitats (Fig. 53). It is highly probable that migrating fish utilise this area to ease the difficult physiological transition between those habitats both on their u/s and d/s. Furthermore, it potentially provides additional habitat for juvenile salmonids, particularly sea trout parr/smolts, which often inhabit such rich feeding areas.

Figure 53. Broad Lough provides a buffer between riverine and marine environments and potentially provides additional juvenile salmonid habitat.

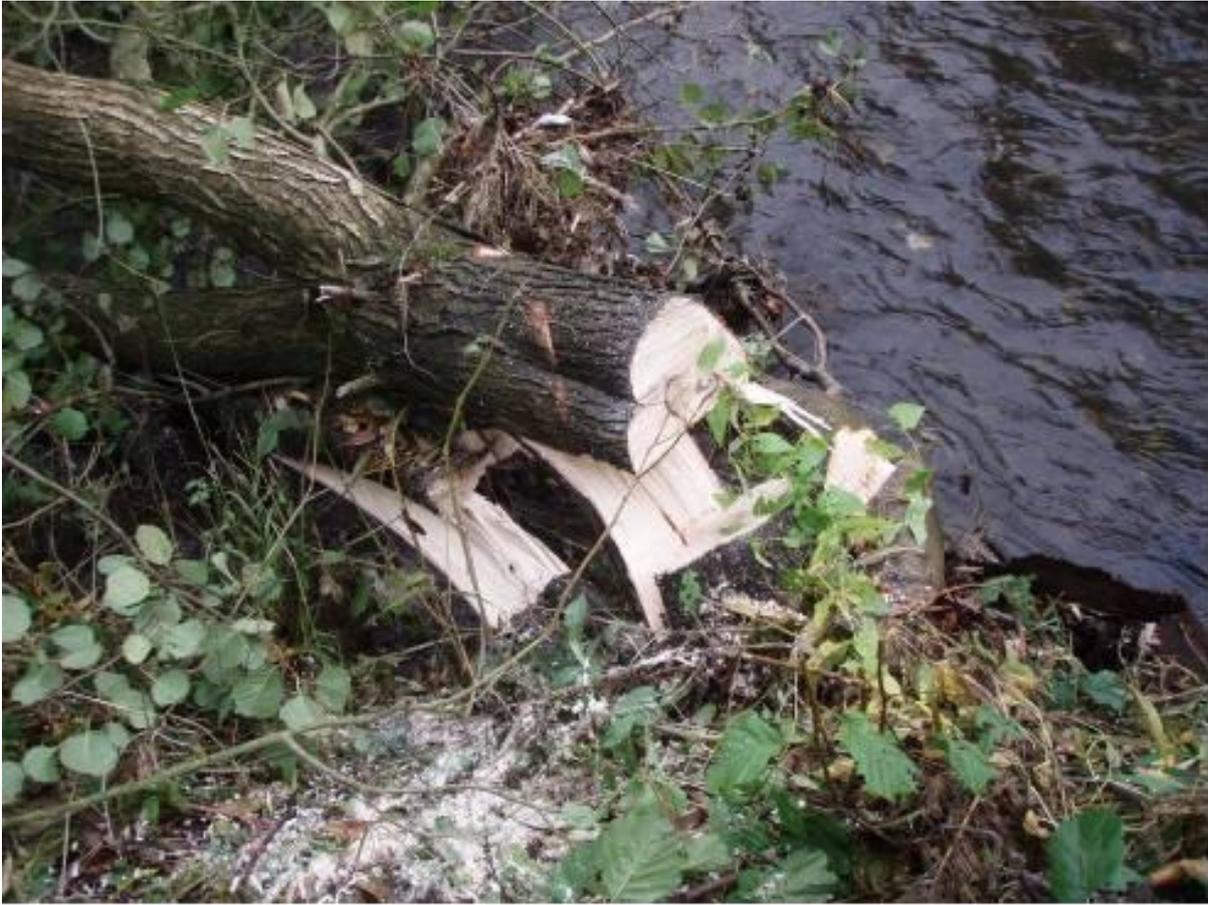
Figure 54. Hinged willow.

The process of laying a tree or branch is simple, it involves cutting part way through the stem/trunk, a little at a time (like laying a hawthorn hedge), until it can be forced over into the channel (Figs. 54 & 55). The depth of the cut should be limited to only that which is required to bend the limb over, as this will retain maximum strength in the hinge and maintain the health of the tree/shrub. On smaller shrubs, simply cutting the stem/trunk at a very shallow angle and then putting an axe blade into the cut and hitting it with a hammer can also help the laying while retaining a good strong hinge.

This is a great method to rapidly increase low cover but should be employed sparingly so as not to detract from other valuable tree habitats. The method is best employed specifically where the additional cover is likely to directly benefit fish holding capacity of an area.
