Advisory Visit

River Vartry, Co. Wicklow, Ireland

24th & 25th February 2016

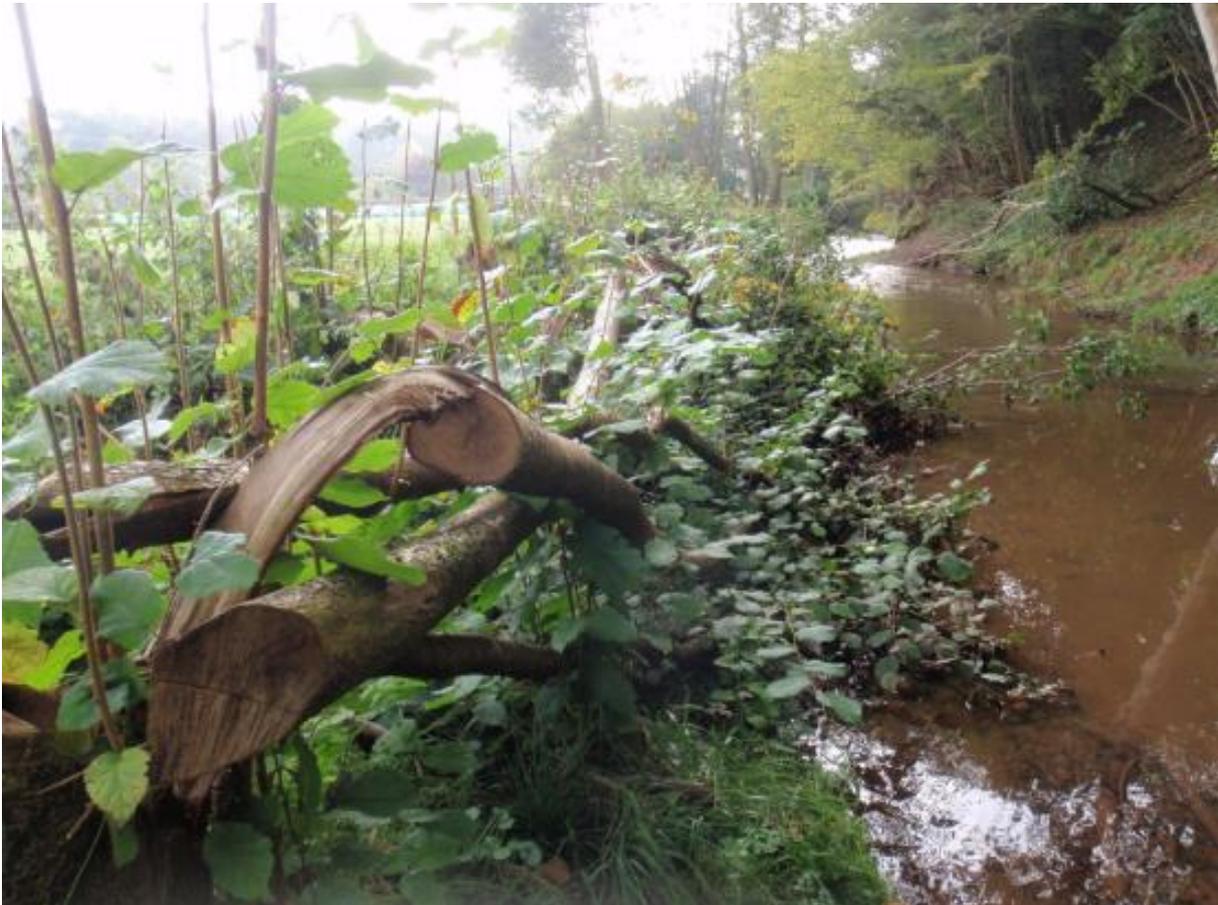
Figure 55. Hinged hazel.

The process of laying a tree or branch is simple, it involves cutting part way through the stem/trunk, a little at a time (like laying a hawthorn hedge), until it can be forced over into the channel (Figs. 54 & 55). The depth of the cut should be limited to only that which is required to bend the limb over, as this will retain maximum strength in the hinge and maintain the health of the tree/shrub. On smaller shrubs, simply cutting the stem/trunk at a very shallow angle and then putting an axe blade into the cut and hitting it with a hammer can also help the laying while retaining a good strong hinge.

This is a great method to rapidly increase low cover but should be employed sparingly so as not to detract from other valuable tree habitats. The method is best employed specifically where the additional cover is likely to directly benefit fish holding capacity of an area.
